# Results of Archaeological Excavation Conducted in Advance of the Front Portico Reconstruction Project at Historic Sandusky (Site 44CP0189), Lynchburg, Virginia.

*Project Number 20110452*

*May 30, 2012*

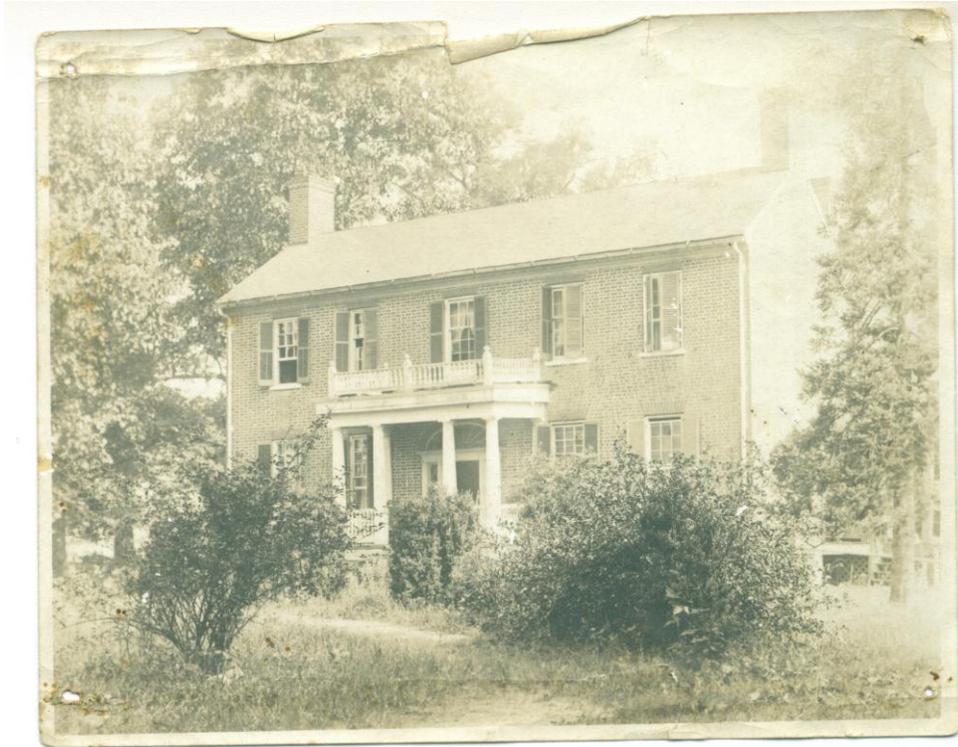
**Figure 3. This undated photograph is likely the earliest depiction of the current portico (courtesy of the Historic Sandusky Foundation, 2012).**

The existing portico is a Tuscan order Greek Revival addition (Figures 3-5). It is attached to the house via tapering square pilasters on either side of the doorway. The portico roof is supported by four 11 inch diameter columns. The portico rests on an enclosed three-sided brick foundation measuring 4.6 m (15 ft.) long by 2.1 m (7 ft.) wide. Wooden stairs span the middle two columns and rest on a large flagstone set flush to the ground. Paint ghosting from an earlier portico is visible on either side of the doorway and replacement bricks mark the locations of joist pockets from an earlier portico frame. A large wooden sleeper, likely from the original portico, had been reused as a center brace beneath the floor of the newer portico (Adams-Doolittle 2009:47-48).

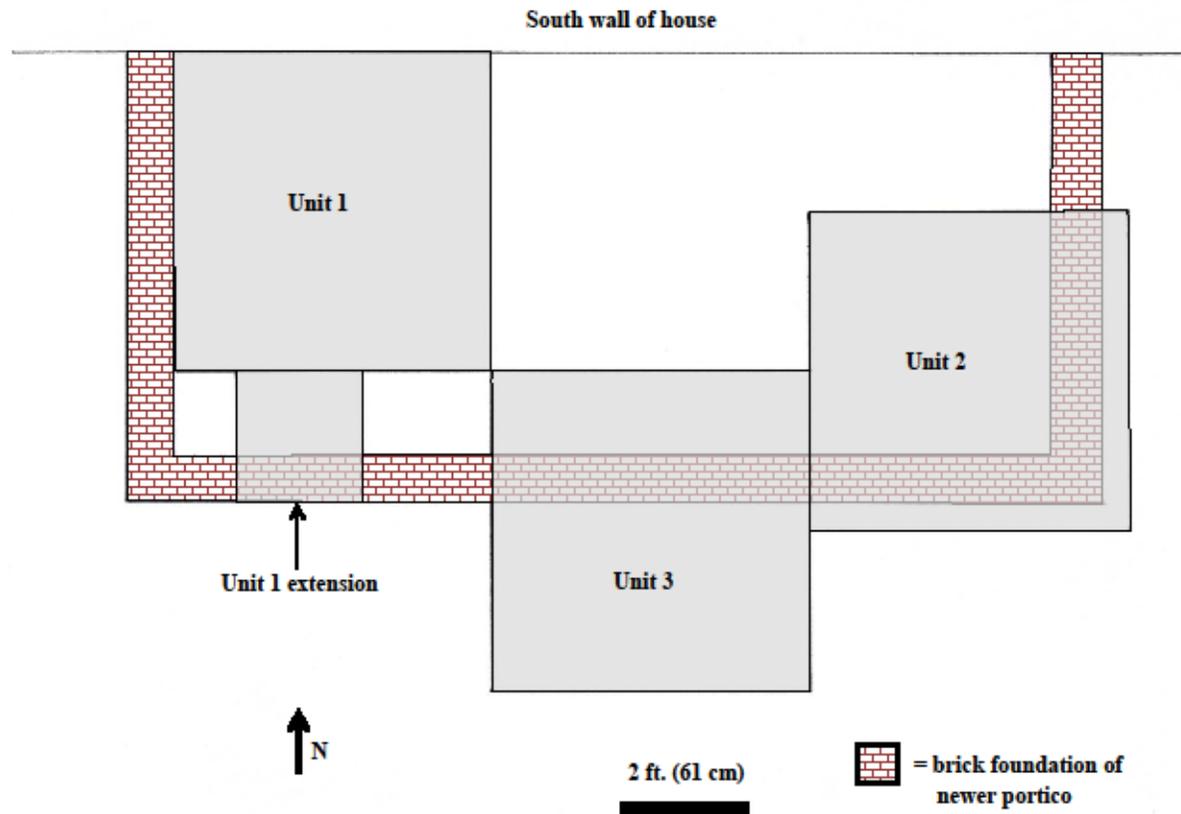
Figure 6. Overall unit placement drawing.

Unit 1 was located such that its northwest corner lay at the intersection of the newer portico foundation and the south wall of the house (Figure 6). This was the only unit to lie entirely in the area that had been covered by the newer portico and would be the only unit excavated to subsoil. The upper-most layer (Layer A) consisted of dry yellowish red (5YR4/6) loam as described above. The approximately 6.1 cm (2.4 in) thick layer was removed by brushing the soil onto dustpans with a hand or trowel. Layer A contained 101 artifacts, including an 1888 Indian Head Cent, 26 cut nails, 15 wire nails, 40 window glass shards, bird bone and a rubber canning jar seal (Appendix A). The layer represented soil that was deposited between the time the first portico was dismantled and the newer portico was built. It also included bits of wood and debris from the recent dismantling of the portico. Although this area had been encased by the newer portico, there was evidence of significant rodent activity in the form of black walnut caches and dried leaves used for nesting. At some point squirrels had likely burrowed under the foundation and up into the hollow cavity beneath the portico. The high proportion of architectural artifacts to domestic artifacts in Layer A is further evidence of its relationship to the nineteenth century portico replacement.

Unit 3 was located diagonally adjacent to Unit 1. The unit also shared the southern half of Unit 2's west wall (see Figure 6). In relation to the house the unit was located just to the west of center of the front door. Several features were present within its bounds at the ground surface. The features consisted of a portion of the large stone slab upon which the newer portico steps rested, the newer portico foundation (Context D), a large quartz stone (Context C) that had recently supported a sleeper for the newer portico (Historic Structures Report p. 48) and a smaller stone of indeterminate function abutting the south side of the newer portico foundation (Figure 24).

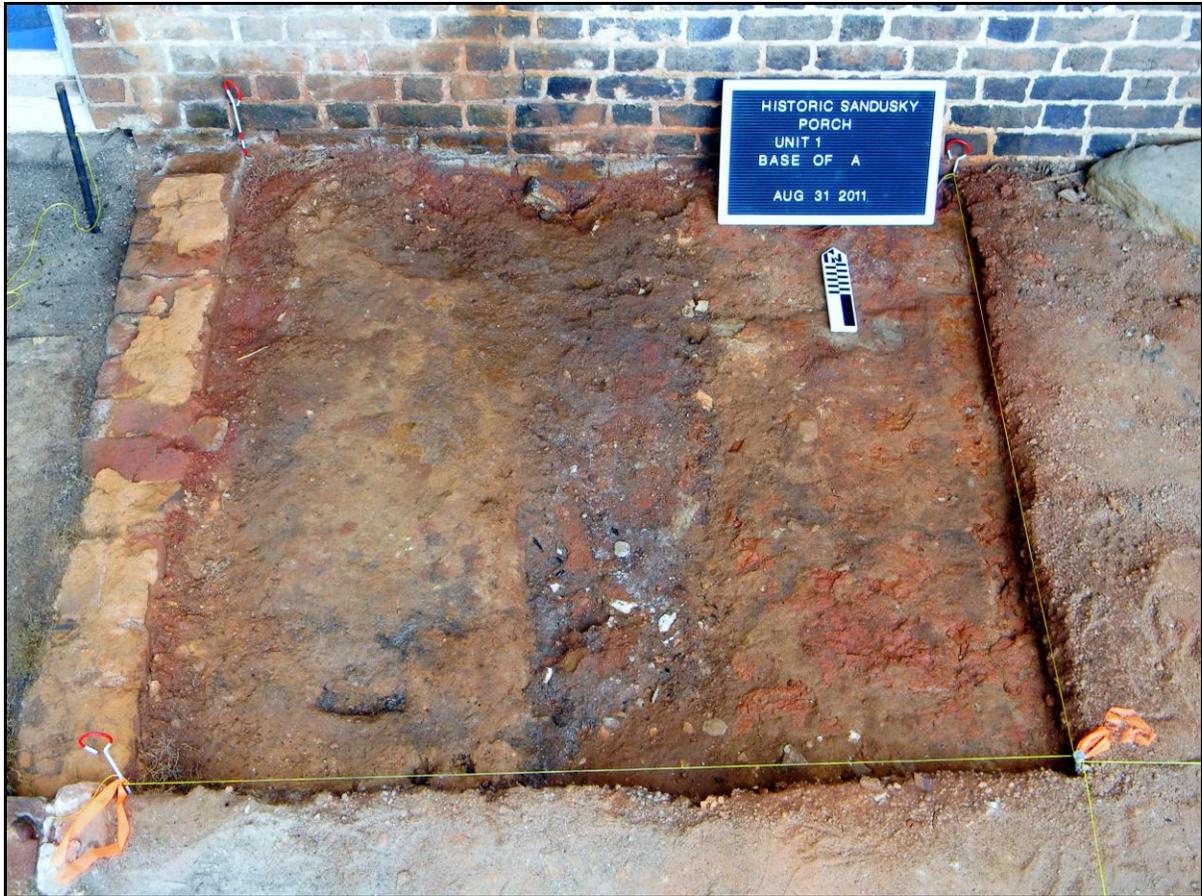
**Figure 7. View of Unit 1 at the base of Context A.**

The transition from Layer A to the layers and features below it was marked by an abrupt change to compacted soils across the unit. Several features could be seen clearly at the interface (Figures 7 and 8). Most significant among these was the backfilled robber's trench from the original portico foundation. Labeled as Context E, the trench was the first of the several features to be excavated. Measuring approximately 33.5 cm (13.2 in) wide, the trench cut north-south across the center of the unit. It lay directly in line with the ghost marks on the house to the west side of the door. Trench fill consisted of dark brown (7.5YR3/4) sandy loam mixed with approximately twenty-five percent brown (7.5YR5/4) sandy loam. Fragments of lime mortar were mixed throughout the trench fill, with several palm-sized pieces found lying at the base of the trench. This feature was bisected east-west. Removal of the southern half revealed a shallow flat-bottomed profile approximately 12.8 cm (5 in) deep (Figure 9). The trench contained 53 artifacts, 44 of which were window glass. Two fragments of rubber canning jar seal were also recovered, along with two bottle glass shards and three cut nails.

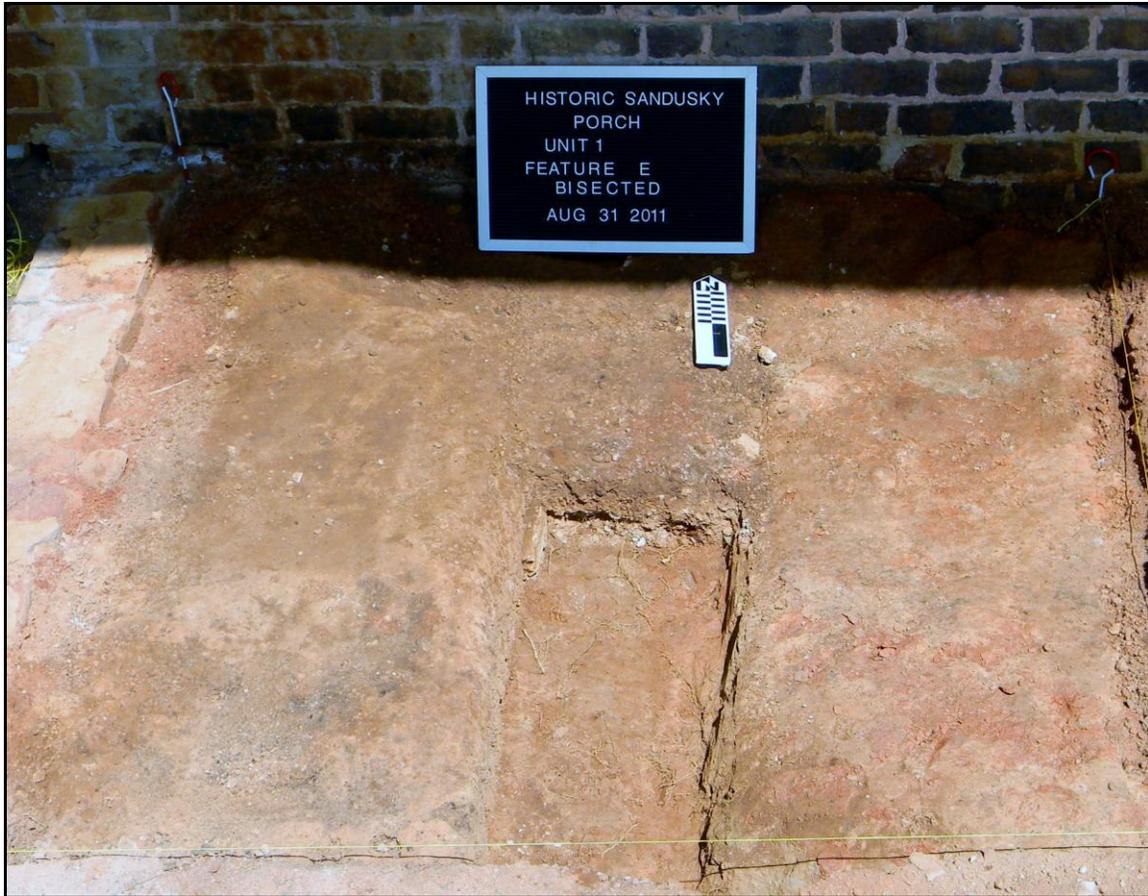
**Figure 9. View of early portico builder's trench profile  
(Context E) in Unit 1.**

Context F was a semi-circular feature that lay along the northeast edge of the robber's trench (Context E) for the older portico foundation. Its fill was comprised of strong brown (7.5YR4/6) sandy loam mixed with bits of mortar. The feature was very shallow, measuring just 1 cm (0.4 in) deep. It was cut by the robber's trench, but its proximity to the old portico foundation suggests it was associated with its construction. No artifacts were recovered from this feature. Visible below Context F and running east-west was a portion of the builder's trench for the house.

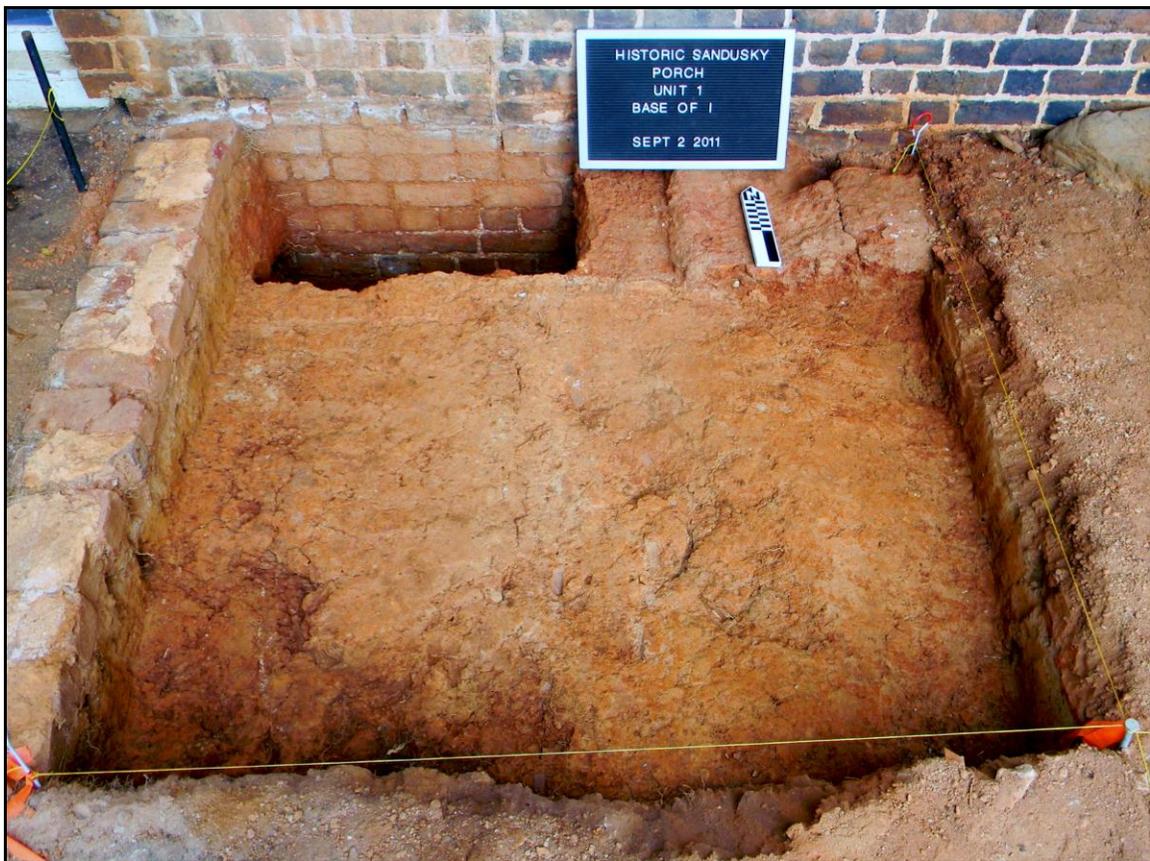
**Figure 10. View of house builder's trench, Context H, in Unit 1.**

Following the removal of Contexts B, C, E, F and G the house builder's trench, Context H, was fully exposed across the northern end of the unit (Figures 10 and 11). The trench extended 43 cm (1.4 ft) south of the house wall on the east side of the unit and tapered to 34 cm (1.1 ft) away from the house on the west side. It was comprised of

relatively loose dark red (2.5YR3/6) clay loam. The trench was bisected north-south with the west side excavated first. During the course of the excavation the trench collapsed into a large rodent burrow lined with cellophane fragments and other artifacts introduced into the context. It was clear that the disturbance continued into the east half of the unit, so excavation of the feature was terminated at 46 cm (1.5 ft) below its surface. The base of the builder's trench was not reached and since it lay below the depth of proposed disturbance for the current undertaking no attempt was made to excavate it to subsoil. The artifact assemblage consisted of cellophane fragments (discarded in the field), a pig long bone, clear bottle and tumbler glass shards, a dark green wine bottle lip shard, window glass, an unidentified nail, burned brick and plaster. The degree of disturbance, however, cast doubt on which of the artifacts may have originated from outside the trench fill.

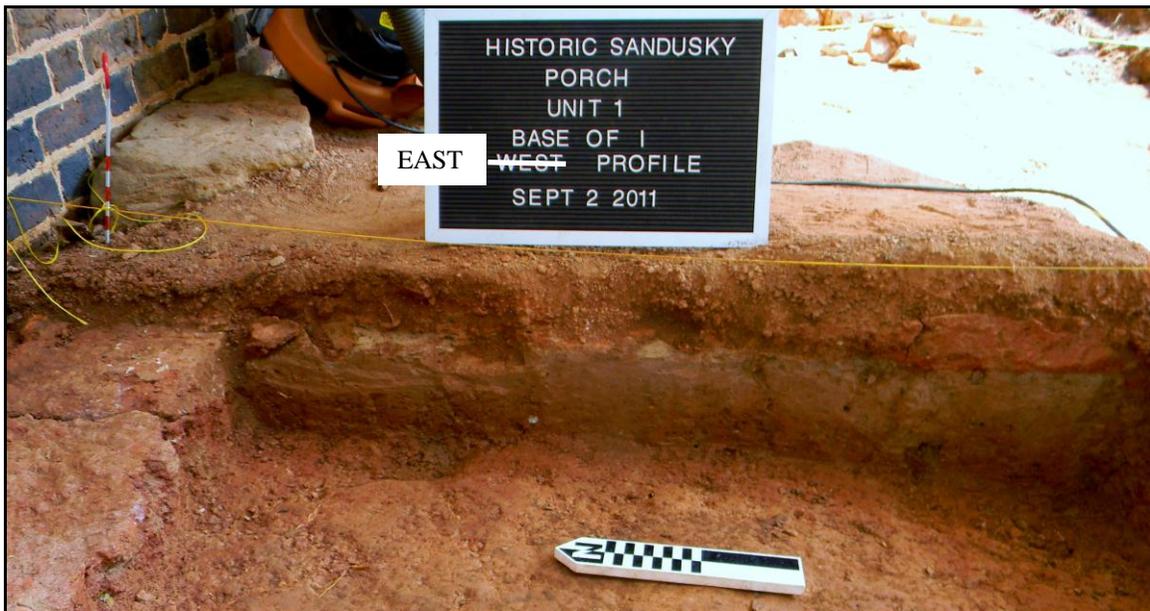
**Figure 12. Unit 1 east profile.**

Finally, after removing contexts A through H, a layer presumed to be pre-house A-horizon was exposed across the entire unit (Figures 12-16). Context I, which consisted of approximately 7.6 cm (3 in) of light brown (7.5YR6/4) silt loam, was excavated to sterile subsoil (dark red (2.5YR3/6) clay loam). The layer contained a total of 5 artifacts and 63.5 g of mortar. These artifacts consisted of an unidentified wood fragment, a bird bone, a dark green bottle glass shard, a window glass shard and a sherd of unglazed earthenware.

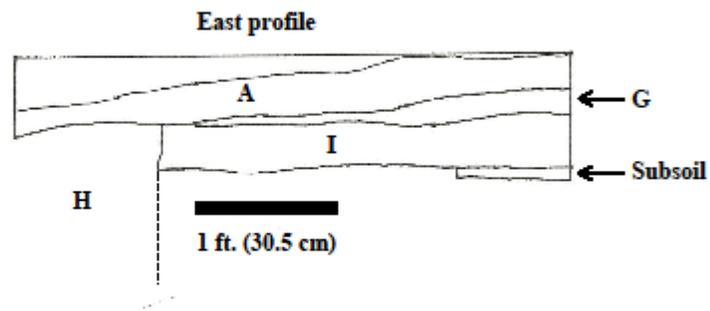
Figure 13. Unit 1 east profile drawing.

A: Layer: Yellowish Red (5YR4/6) Loam

G: Feature: Strong Brown (7.5YR4/6) Sandy Loam

Subsoil: Dark Red (2.5YR3/6) Clay Loam

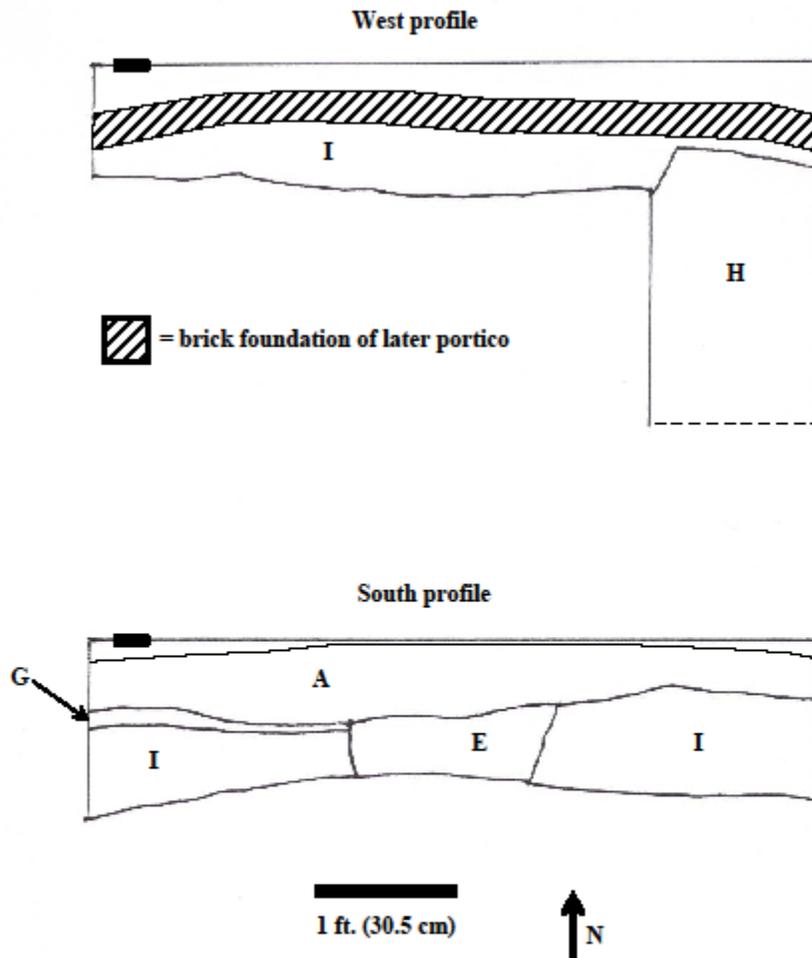
Figure 16. Unit 1 west and south profile drawings.

A: Layer: Yellowish Red (5YR4/6) Loam	H: Feature: Dark Red (2.5YR3/6) Clay Loam
E: Feature: Dark Brown (7.5YR3/4) Sandy Loam mixed with 25% Brown (7.5YR 4/6) Sandy Loam with Mortar	I: Layer: Brown (7.5YR4/4) Silt Loam
G: Feature: Dark Red (2.5YR3/6) Clay Loam

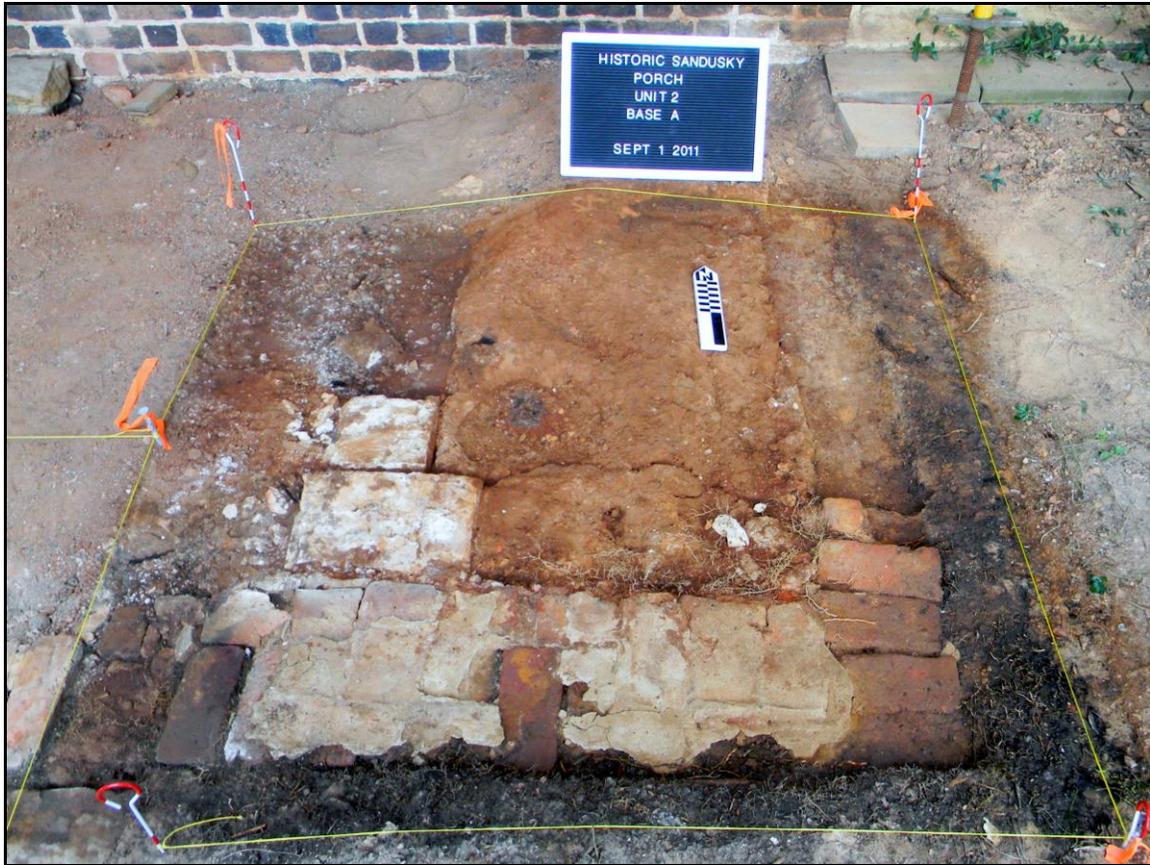
**Figure 17. View of features at the base of Context A in Unit 2.**

Also, as in Unit 1, a variety of features were clearly visible at the base of Context A (Figures 17 and 18). The partial brick foundation of the old portico, designated Context H, was the most prominent of the several features. The foundation lay in the southwest quadrant of Unit 2, just to the south and west of a posthole (Context G) which retained the base of a roughly square wooden post (Context F). Other contexts visible at this depth included a jumble of brick, mortar and artifacts to the north and west of the old brick foundation (Context E), the bricks and large patches of mortar (Context C) related to the newer portico foundation, the area of exposed soil directly beneath portions of the robbed out newer foundation (Context D) and the modern topsoil located to the east and south of the newer foundation (Context B). Finally, excavators recorded the layer between the new and old portico foundations as Context I on the plan drawing, but this layer was not excavated due to time constraints. It lay in the same relative position and appeared similar in composition to Context C in Unit 1.

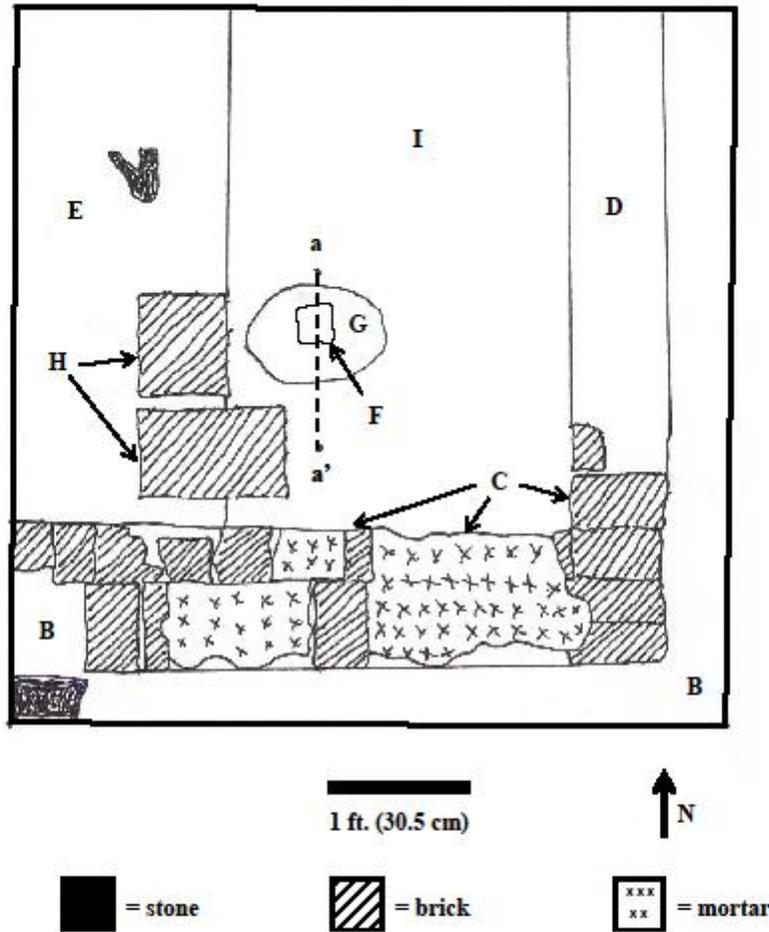
**Figure 18. Plan drawing of features at the base of Context A in Unit 2.**

B: Layer: Dark Grayish Brown (10YR3/2) Loam	F: Feature: wooden post base
C: Feature: later portico foundation	G: Feature: Reddish Brown (5YR3/4) Silty Clay Loam
D: Feature: Strong Brown (7.5YR5/6) Silt Loam mixed w/5% Light Brown (7.5YR6/4) Silt Loam	H: Feature: original portico foundation
E: Feature: Brown (7.5YR4/4) Loam	I: Layer: unexcavated

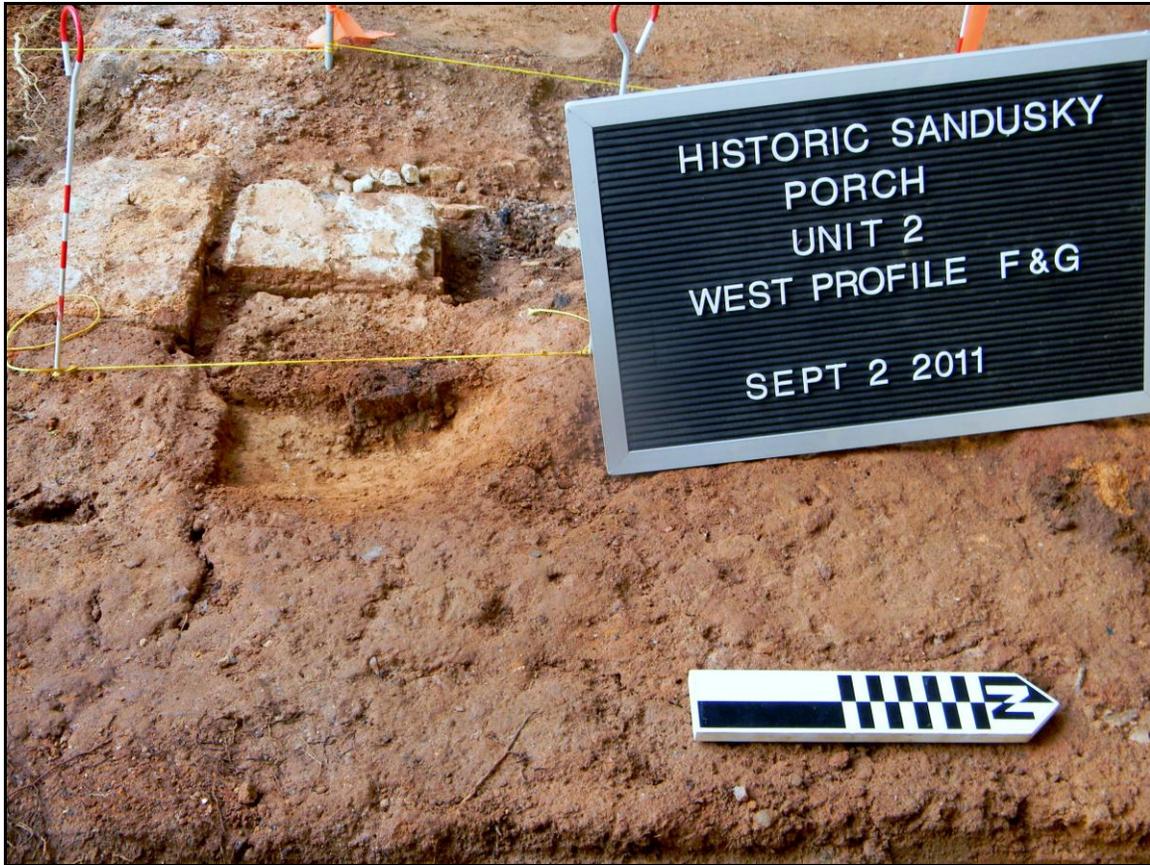
Figure 19. West profile view of bisected post hole (Context G) in Unit 2.

Having removed all traces of the newer portico from the unit, excavators turned their attention to the post and post hole feature. The post hole (Context G) was first bisected north to south. The east half of the feature was removed to expose the post fragment in the west profile of the fill (Figures 19 and 20). The west half was then removed along with the post fragment (Context F). The post measured 7.6 cm (3 in) long and 6.4 cm (2.5 in) wide and had been oriented with its long axis running north to south. No artifacts were recovered from the dark reddish brown (5YR3/4) silty clay loam feature fill, which measured just 1.5 cm (0.6 in) thick.

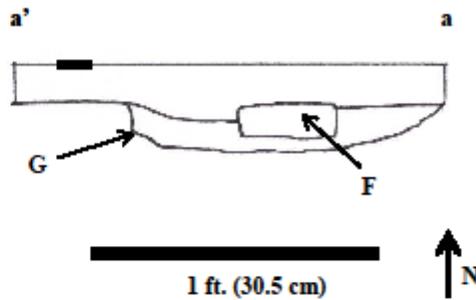
F: Feature: wooden post base

G: Feature: Reddish Brown (5YR3/4) Silty Clay Loam

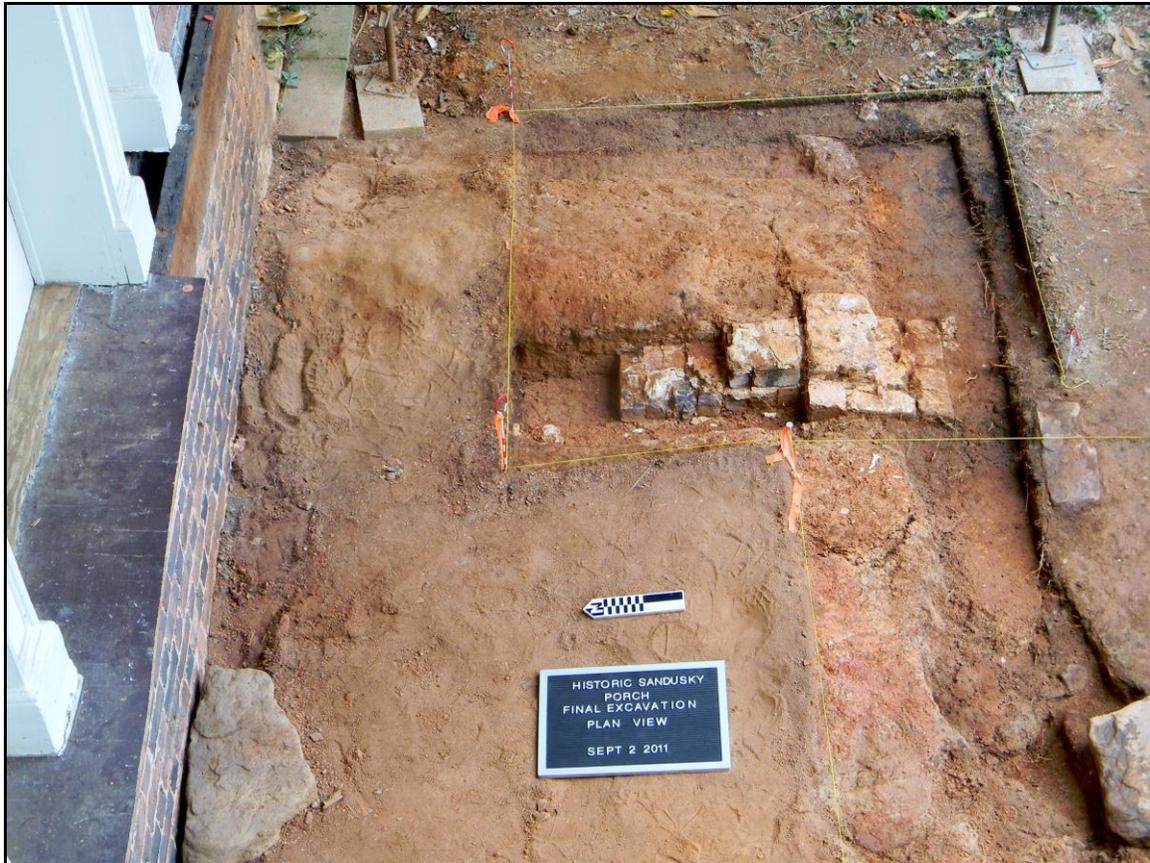
**Figure 21. Old portico foundation (Context H) fully exposed in Unit 2.**

Excavation of Context E revealed the full extent of the older portico foundation (Context H) (Figure 21). The column portion of the foundation consisted of a square brick pad measuring 39.6 cm (15.6 in) on each side, or two brick lengths. Only the bottom course of the column, consisting of 8 whole bricks, remained fully intact. Three bricks that had been part of the second course remained in place at the northeast corner. A short segment of the foundation wall extended northward toward the house from the center of the column. The wall was a single brick in width containing a bottom course laid rowlock style (long side of the header oriented vertically) and a second course with headers exposed. The bottom course retained seven bricks while only the two closest to the column remained in the second course. Although not enough remained of the foundation to determine the type of bond used, it may have mirrored the main house where English bond was employed below ground level with Flemish bond above (Figure 22).

Excavation revealed the earlier portico foundation to be 2.96 m (9.7 ft.) long east-west from outer wall to outer wall. This makes the original portico significantly smaller ((1.6 m (5.3 ft.)) than its 4.6 m (15 ft.) replacement; a conclusion suggested by the much narrower set of ghost marks on the building (Figures 29 and 30). The width of the earlier portico matches fairly closely with the replacement measuring just 9.1 cm (3.6 in.) shorter at 2.0 m (6.7 ft.). The archaeological evidence indicates that the porticoes differed stylistically. The later Greek Revival structure features a single course wide three-sided brick foundation. The original portico, however, consisted of two single-course brick walls extending southward from the front of the house. The walls terminated at what appear to have been brick columns. This design likely would have had a wooden front side with steps extending down from the center. Two post/posthole features (Unit 1 Context D and Unit 2 Context F/G) located just to the outsides of the original foundation may represent scaffolding erected during construction of the portico. H&P and the VDHR have identified several examples of federal porticoes in Lynchburg but further architectural fieldwork will be required to verify an example that matches the Sandusky remains (Figure 31). To date, the best overall match is the portico of the Israel Grafius House in Huntingdon County, Pennsylvania (Figure A). It features a foundation composed of two brick extensions from the main house with an all-wooden center, much the way Sandusky's original portico would have been configured.

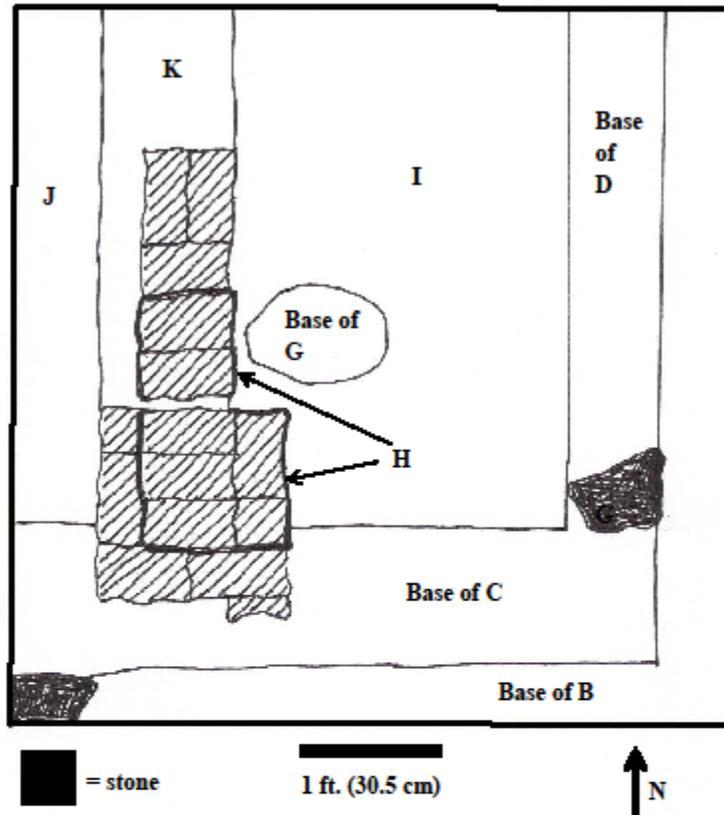
No further excavation took place within Unit 2 due to the lack of time and resources. However the entire surviving portion of the original portico foundation and features directly related to it had been exposed and documented (see Figure 21; Figure 23). Archaeologists assigned Context J to the layer of soil exposed to the west of the older portico in order to collect a shard of clear glass tumbler and a flat glass shard that were fully exposed on the surface before completing photographs and plan view drawings of the unit.

H: Feature: Brick foundation of original portico

I, J and K: Assigned letters but not excavated

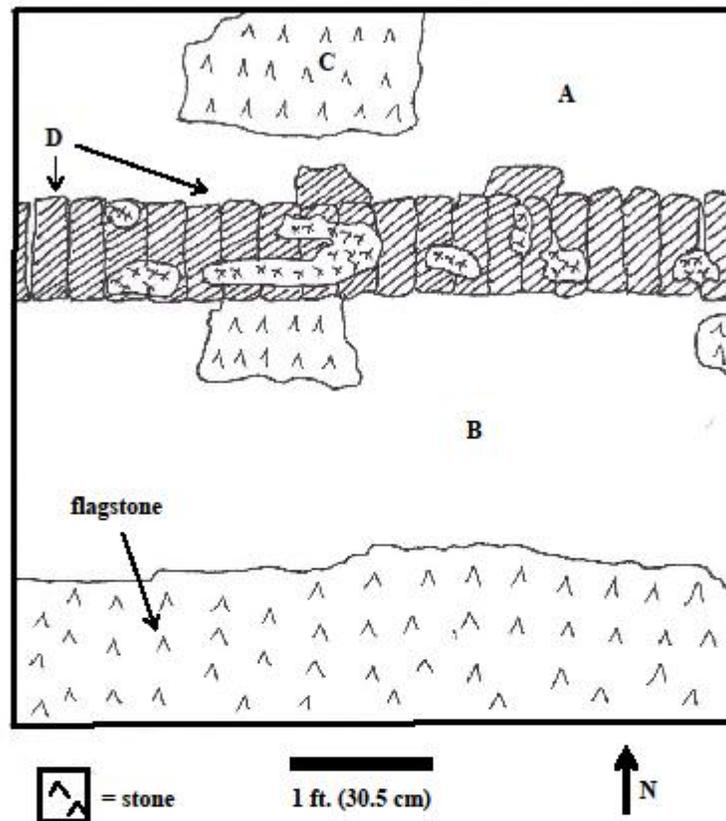
**Figure 24. Plan drawing of Unit 3 prior to excavation.**

- A: Layer: Yellowish Red (5YR4/6) Loam
- B: Layer: Yellowish Red (5YR4/4 to 5YR4/6) Loam
- C: Feature: Quartz Stone – support for newer portico
- D: Feature: Brick foundation and mortar associated with newer portico

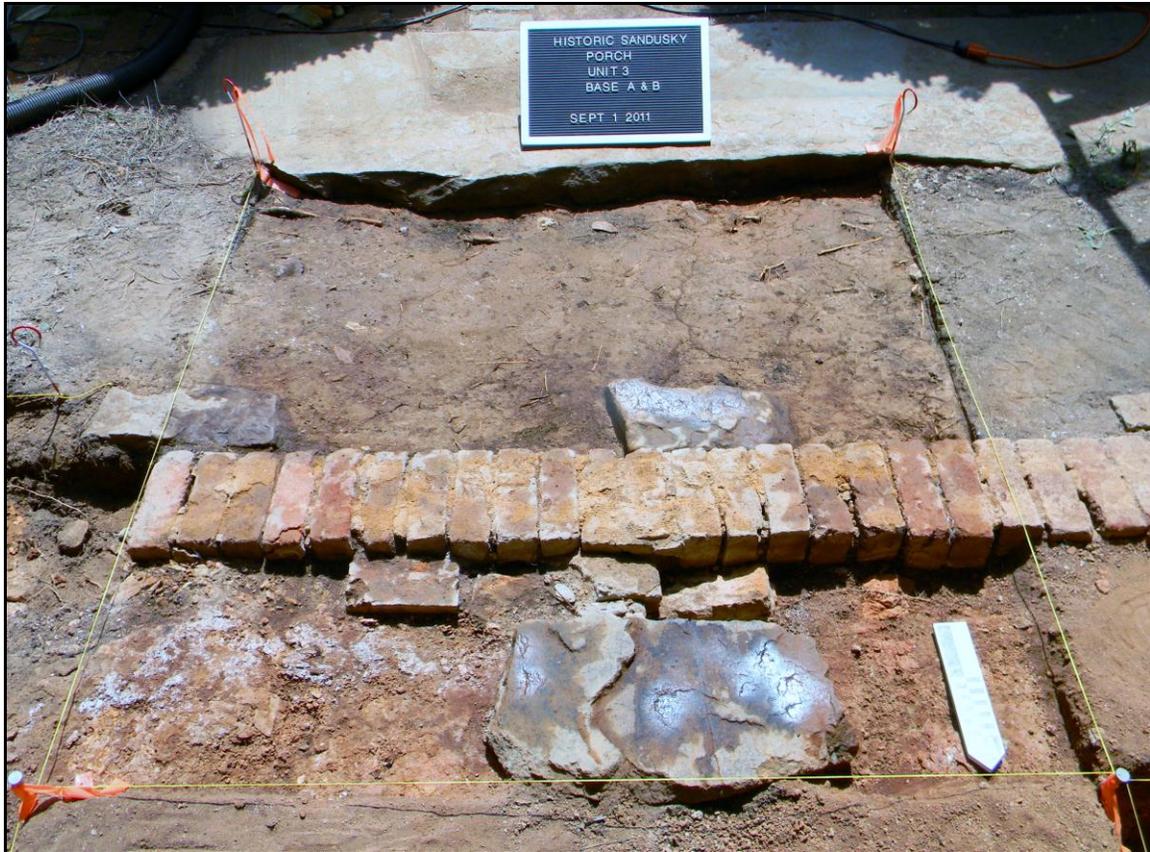
**Figure 25. Plan view of Unit 3 at the base of Contexts A and B.**

Context B was comprised of the topsoil located to the south of the newer portico foundation. This layer had been covered until recently by the wooden portico steps. Soil in this layer was comprised of yellowish red (5YR4/4 to 5YR4/6) loam. As anticipated the layer produced a variety of historic and modern artifacts, including wire and cut nails; decking screws, plastic, paint and wood chips; a .22 caliber shell and a 1972 U.S. quarter. A second flat stone was uncovered near the surface of the layer at the east edge of the unit and just south of the newer portico wall. It was similar in both size and alignment to the stone noted above that was situated to its west (Figures 25 and 26). These stones, and a single brick further to the west, looked to have been intentionally placed but had no current function. Given their proximity to the newer portico wall they may have served as footers for upright braces at the back of the steps. However, no uprights existed at the time the steps were removed for the current rebuilding project. It is also possible that the stones were related to the older portico steps in some manner. The base of layer B was marked by the appearance of numerous horizontal roots and two rodent burrows. The burrows ran east to west at the edge of the large landing stone and near the center of the unit at the edge of the portico wall.

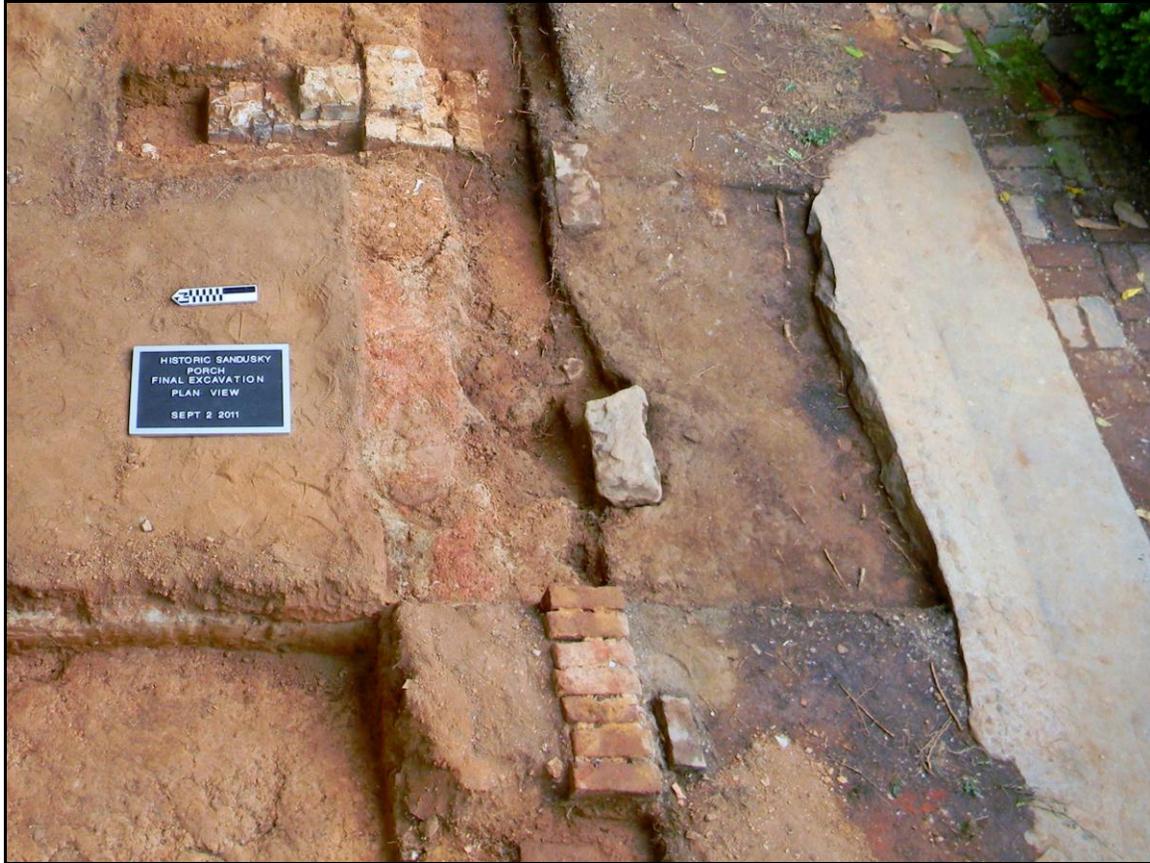
**Figure 27. Plan view of Unit 3 at the conclusion of excavation.**

Context G, the last to be excavated in Unit 3, was a feature that lay along the northern edge of the unit. It was situated beneath layer A and had been located beneath the newer portico. This feature consisted of strong brown (7.5YR4/6) clay loam measuring approximately 3 cm (1.2 in) thick. A total of 23 artifacts were recovered, including 11 clear flat glass shards, 7 cut nails/fragments, 1 pearlware rim sherd, 1 undecorated porcelain rim sherd, 2 clear vessel glass shards and a prehistoric quartz flake. The context also included a copper alloy button with a rouletted rim and possible floral pattern. Weighed artifacts from the feature consisted of charcoal, mortar and primer paint chips. The feature extended into the north wall of the unit and may represent a lens related to construction of the newer portico (Figure 27).

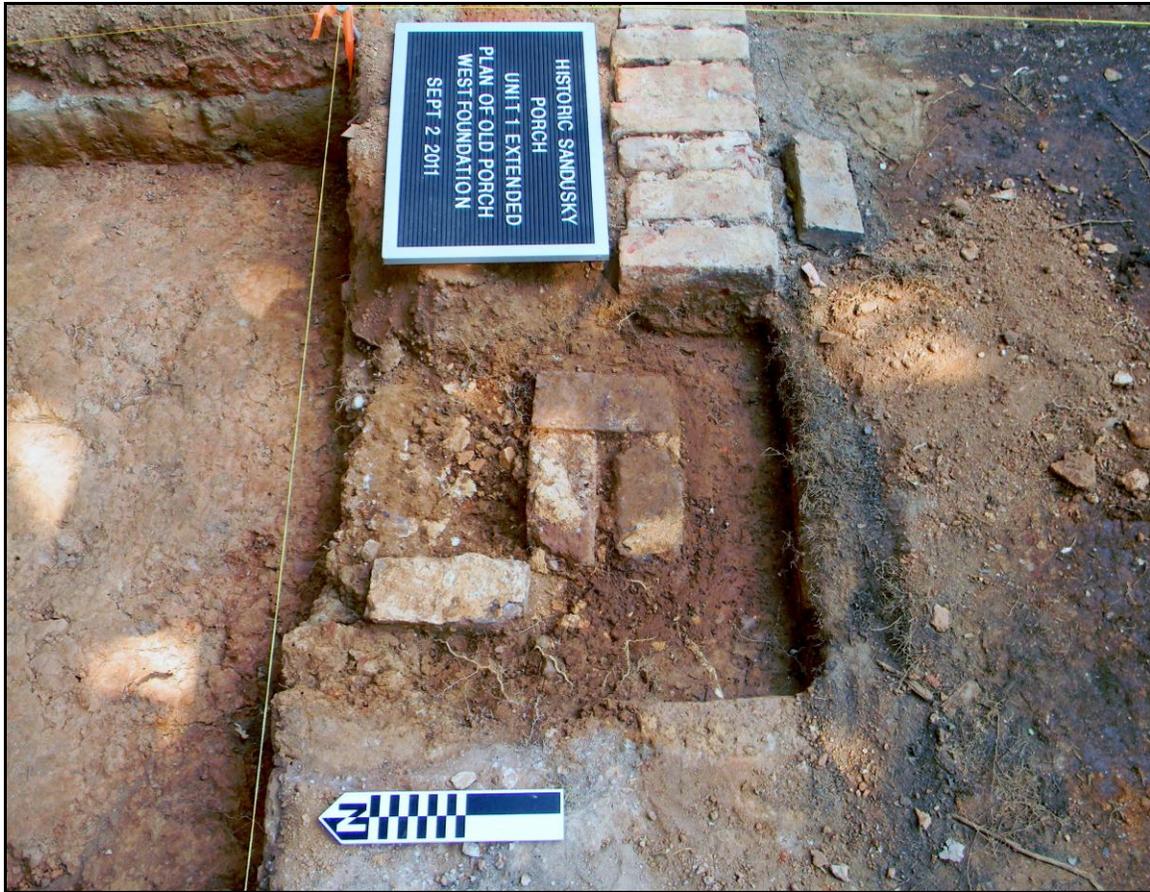
**Figure 28. Plan view of column base after excavation of Context A in Unit 1 Extension.**

The soil in this area (Context A) matched layer A of Unit 1, consisting of 3 cm (1.2 in) of dry yellowish red (5YR4/6) loam. Due to time constraints the layer was not screened for artifacts. Excavation revealed that only four bricks of the bottom course of the column remained in situ (Figures 28). The bricks aligned with the robber's trench in Unit 1 and the ghost marks on the house's south elevation. They were also symmetrical to the column remains discovered on the east side of the door.

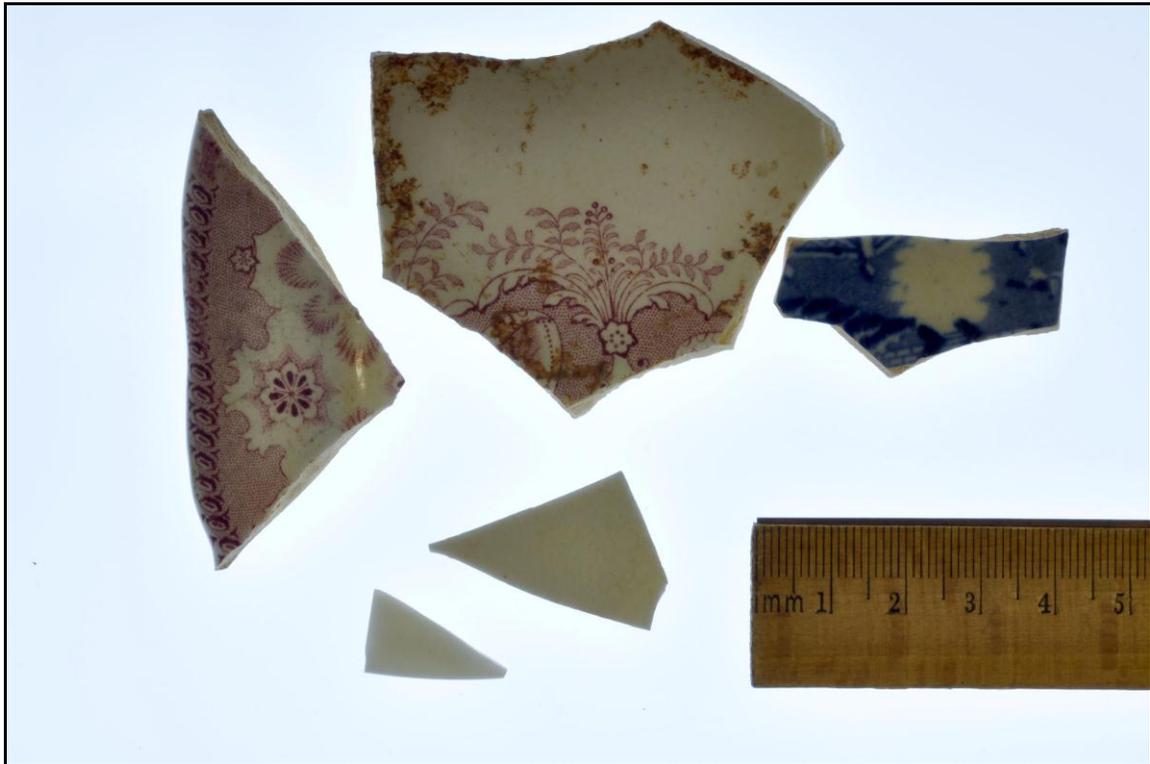
**Figure 30.** Clockwise from top left, red transfer-printed whiteware, blue transfer-printed pearlware and undecorated porcelain (ER2-E).

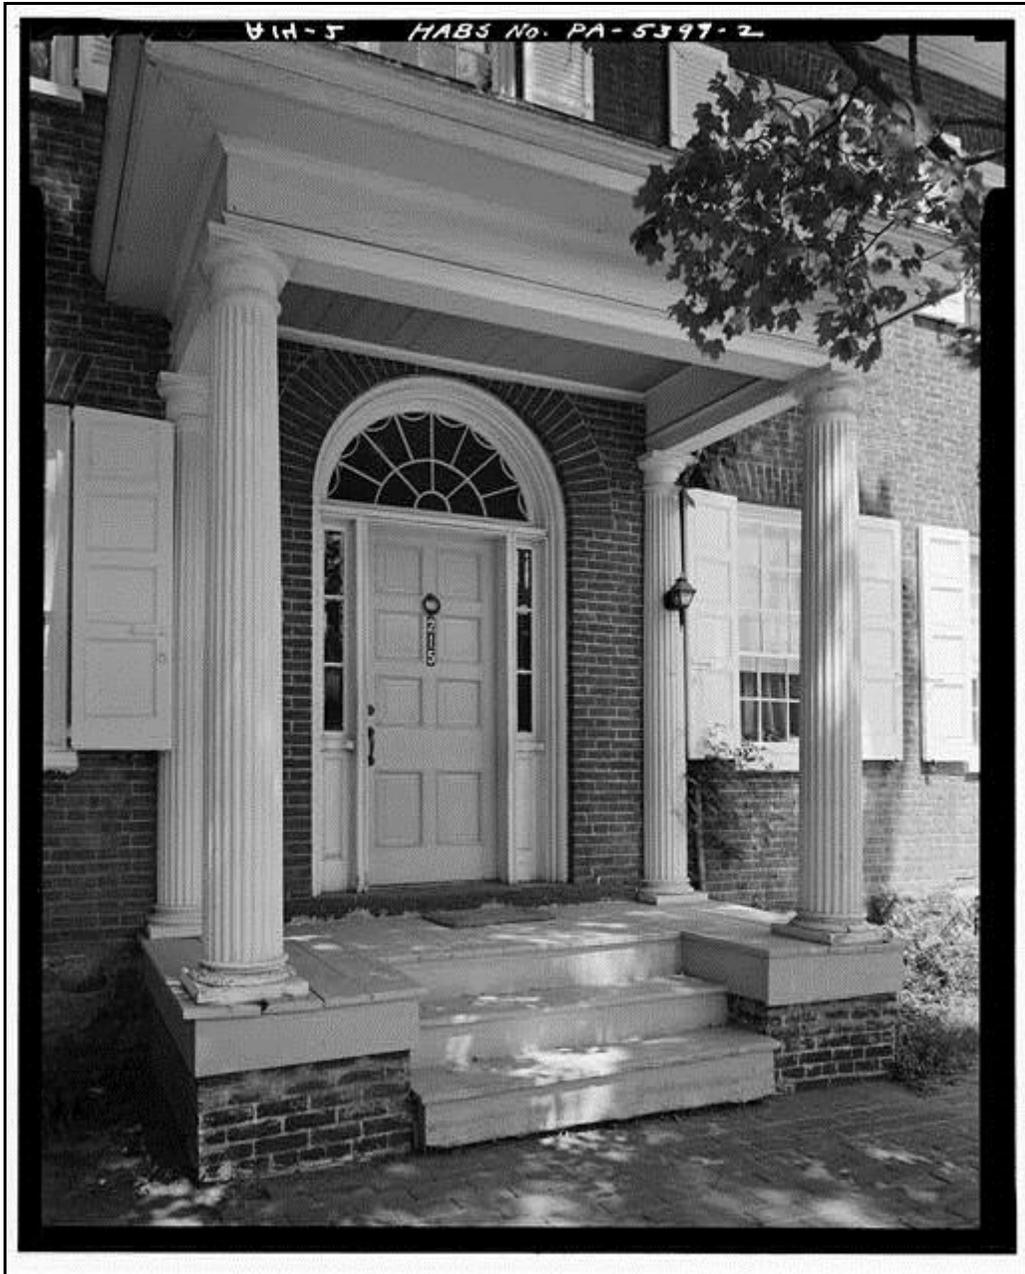
**Figure 36. Portico of the Israel Grafius House (c. 1802), Huntingdon County, PA (Library of Congress, Prints and Photographs Division).**

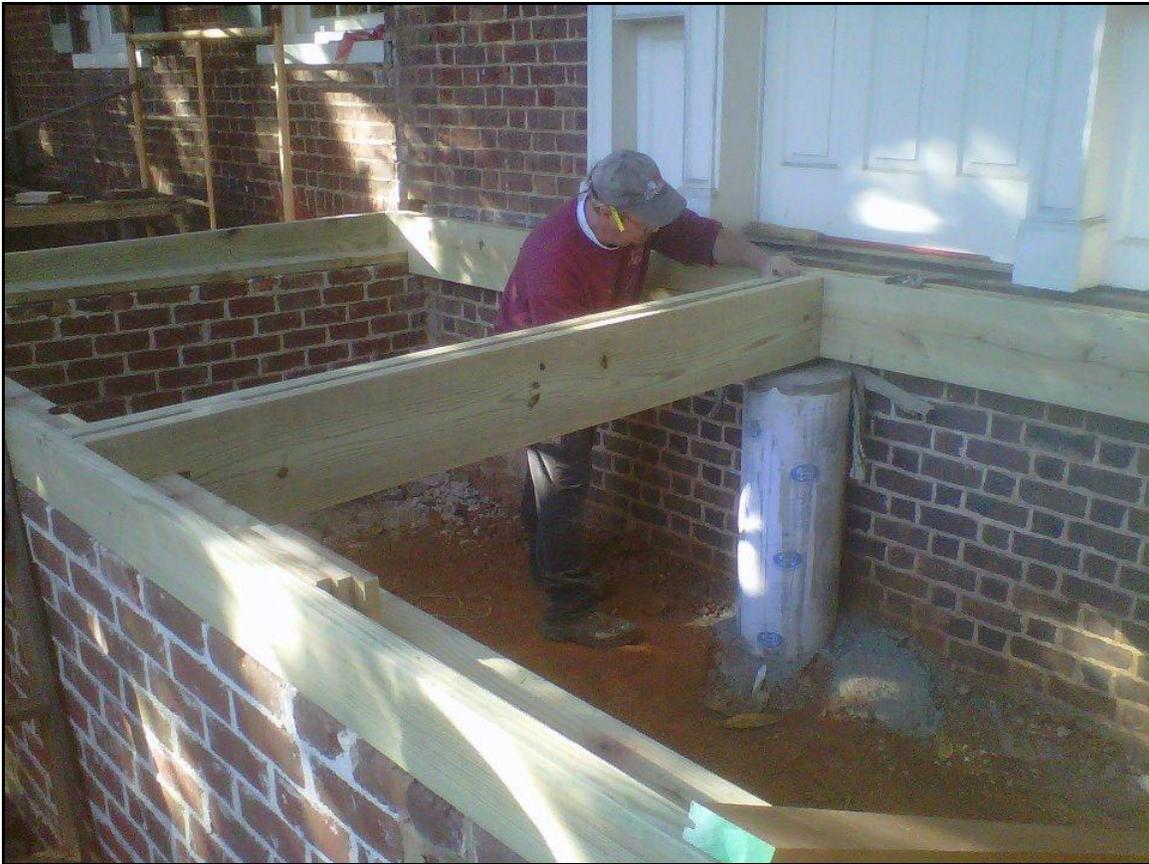
**Figure 37. View of the concrete footer for the reconstructed portico (courtesy of the Historic Sandusky Foundation, 2012).**

reconstructed portico floor. H&P was unaware of plans to pour the column, but a photograph taken during the reconstruction suggests that it disturbed only a maximum 2 x 2 foot area (Figure 32).
