## **Cross-section Paint Microscopy Report**

### **Interior Paints Historic Sandusky, Lynchburg, Virginia**

Date: May 31, 2013

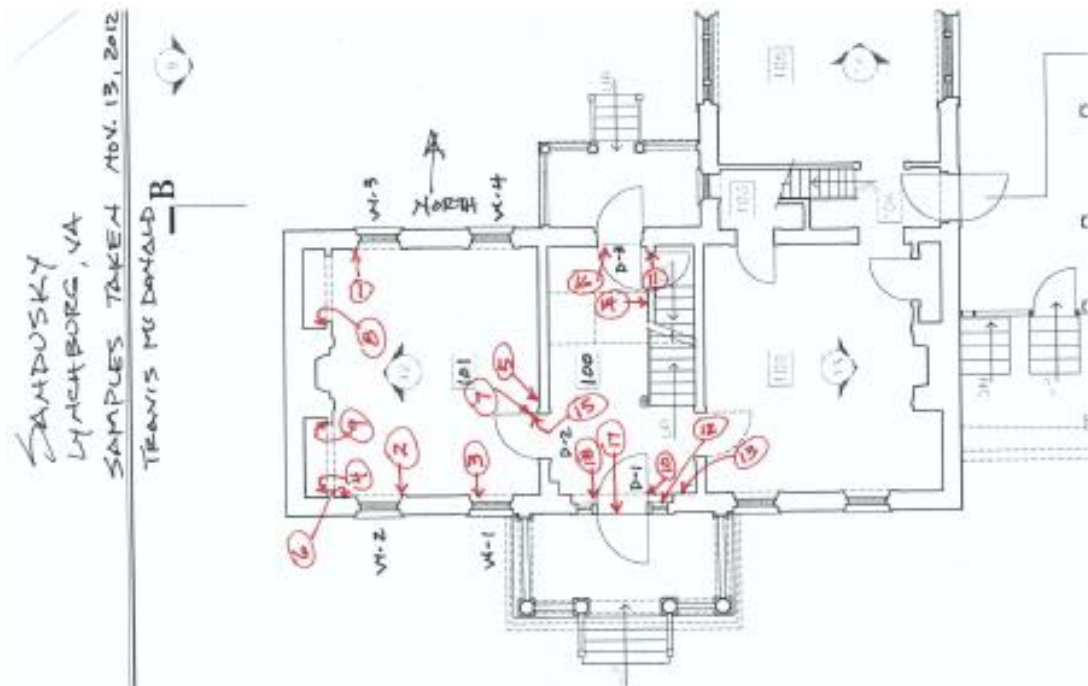
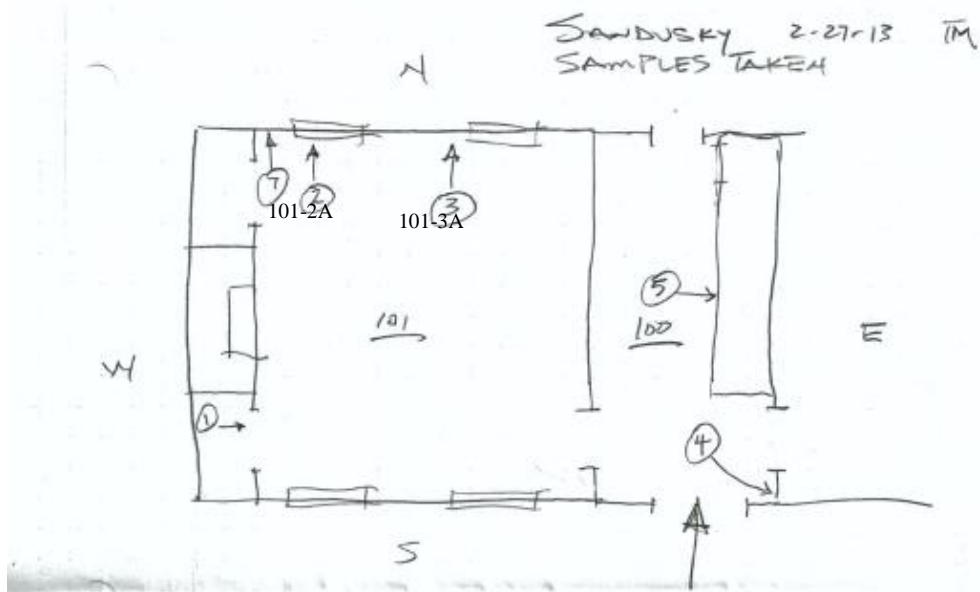
Parlor and Entry Woodwork Sample Locations

The original gray paint on the door (101-7) and one baseboard (101-3) were found to be the same gray paint observed on the trim elements. The first layer in sample 101-5, from an applied molding on the wainscoting, is a coarsely ground light blue paint, not gray. The work on-site revealed that the original palette in the parlor actually consists of gray and blue to pick out alternating moldings. The gray/blue palette is followed a dull pink paint identified as the second generation on the woodwork in the parlor. This dull pink paint coincides with the use of dull green to pick out specific moldings. There is also a recognizable grain-painting sequence on the door (100-10) and surbase (101-3A) in the second generation, which may have been a faux finish to replicate mahogany. The sample locations are shown in the sketches provided by Travis McDonald.

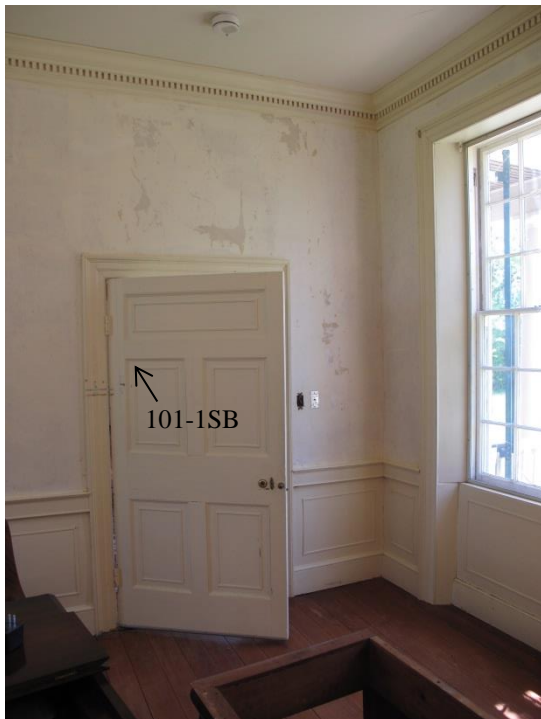
East Wall Door

Comparative analysis suggests that the doors (samples 101-7 and 100-10) were initially painted the same gray as the wainscoting and trim, then they were grain-painted in the second generation (samples 101-1SB and 100-10). This may have been mahogany graining as the base coat is a pink color that was typical of traditional graining craft practice to replicate mahogany, with the base color as the lightest color of the figure of the wood being imitated.

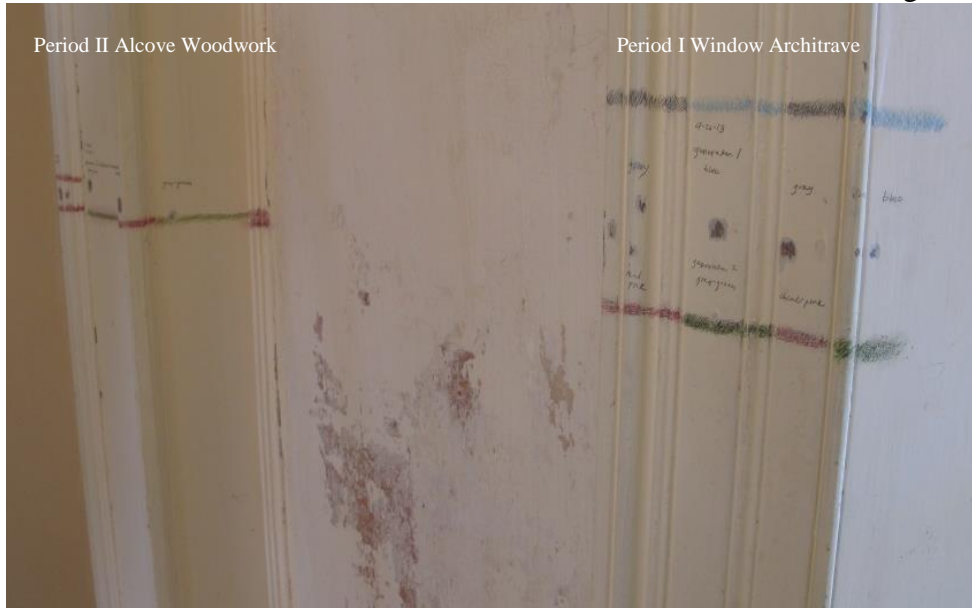
Period I (Blue/Gray) and Period II (Dull Pink/Dull Green) Color Palettes For Room 101 Alcove Woodwork and Window Architraves Based on On-site Investigations

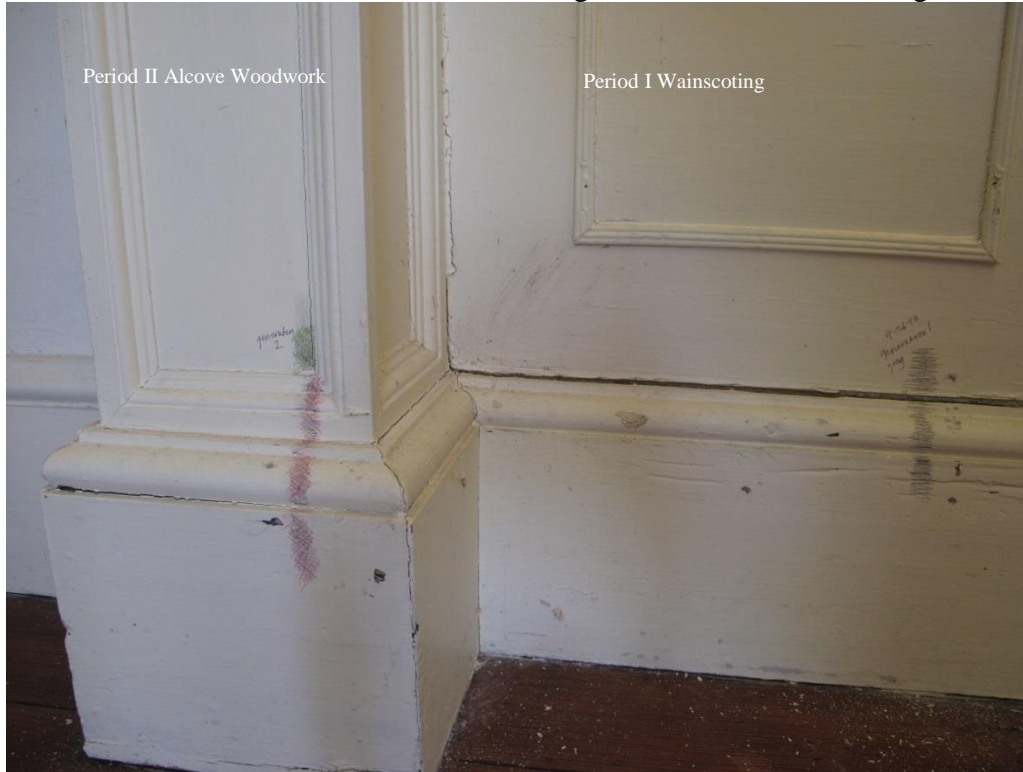
Period I (Blue/Gray) and Period II (Dull Pink/Dull Green) Color Palettes For Room 101  
Alcove Pilaster, Baseboards and Wainscoting Based on On-site Investigations

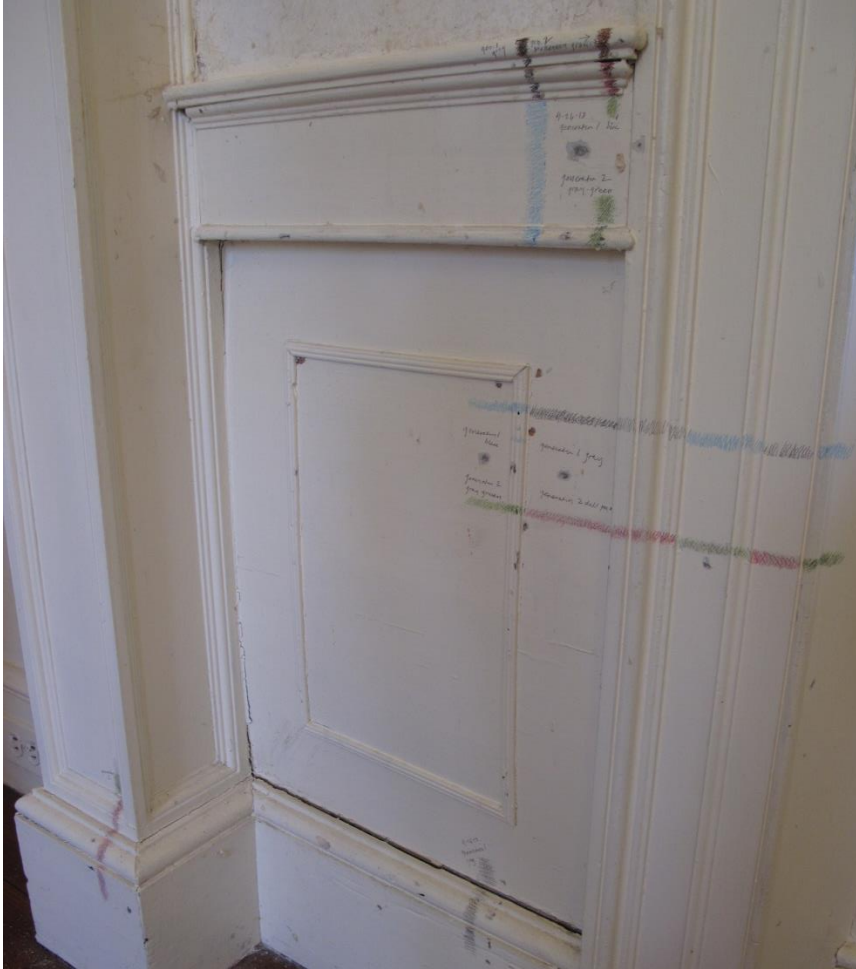
**Period I (Blue/Gray) and Period II (Dull Pink/Dull Green) Color Palettes for Room 101  
Wainscoting and Window Architrave Based on On-site Investigations**

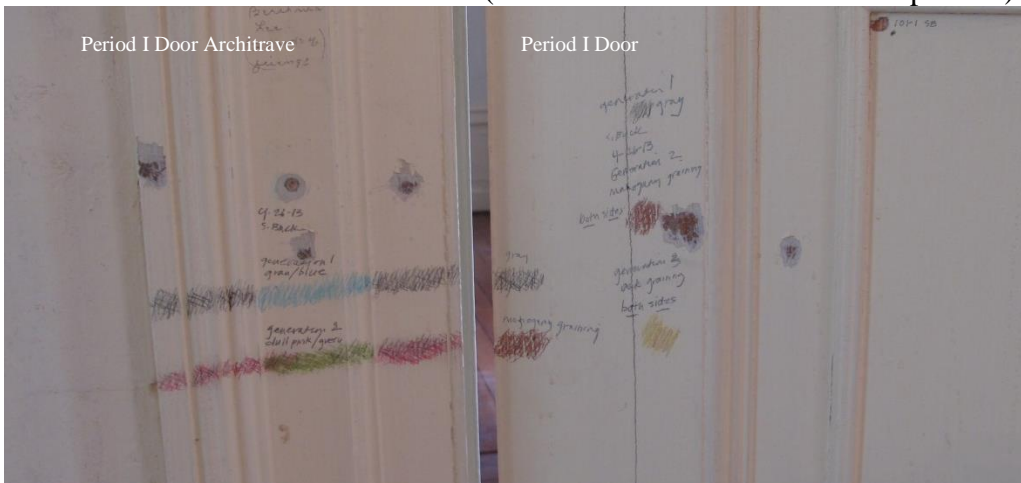
**Period I (Blue/Gray) and Period II (Dull Pink/Dull Green) Color Palettes for Room 101  
East Wall Door and Door Architrave (in Period II the Door was Grain-painted)**

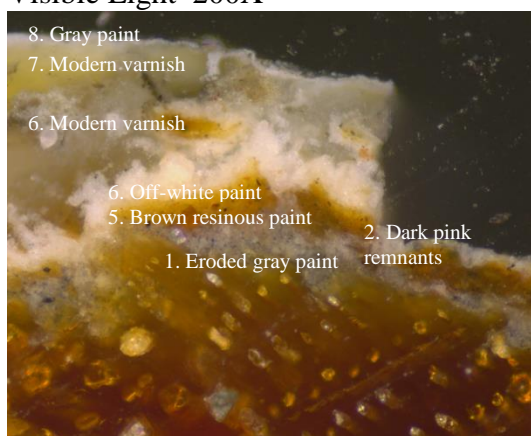
Visible Light 200X

Sample 101-2. West window trim, south wall (similar to 1). The layers on the window trim are quite disrupted and uneven, but the original gray paint remains trapped in the wood, above a shellac sealant (identified based on its orange autofluorescence under reflected ultraviolet light). The first gray paint is so eroded that in some areas the wood fibers are exposed. In an uncast portion of this sample it is also possible to see the dark pink paint found as generation 2. The cream-colored and off-white paints found as generations 3 and 4 in this room are missing. The glossy brown paint in generation 5 was not found elsewhere in the room, and it is followed by an off-white paint and several weathered varnishes. When the window trim was examined on site it was possible to see that the window architraves were repainted in the same manner as the door architrave and wainscoting.

Sample 101-2. West window trim, south wall (similar to 1).

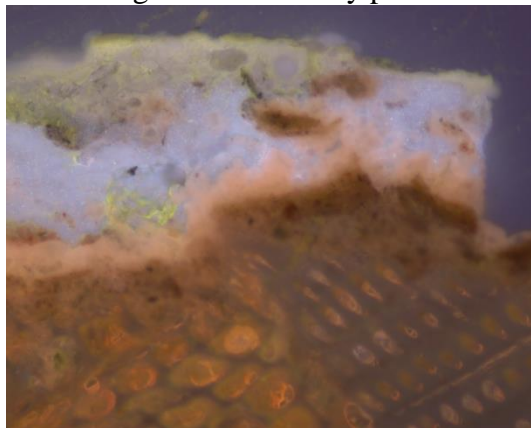
All coatings reacted weakly positive for saturated (cross-linked) oils

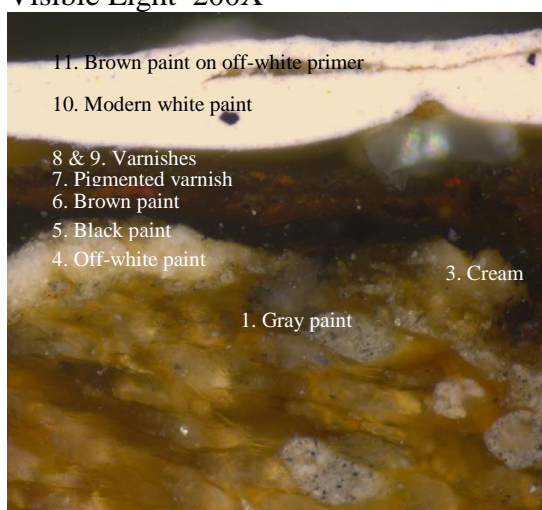
Sample 101-3. South wall base molding below east window (compare to 101-4).  
Visible Light 200X

Sample 101-3. South wall base molding below east window (compare to 4). The paint stratigraphy in this cross-section begins with the same eroded gray paint found on the doors (101-7 and 100-10), followed by remnant of cream-colored paint, an off-white paint, and then a thin black paint. Black paint appears in generation 5 in sample 100-14 from the base molding below the stair, so the baseboards in both rooms were most likely painted black at the same time. It also shows that generation 2 is missing in this cross-section, possibly because of abrasion, because examinations of the baseboard plinth in other locations in the room show that it was repainted each time the room was repainted. The baseboard appears to generally have been the same as the woodwork color until generation 5 when it started to be picked out in dark colors.

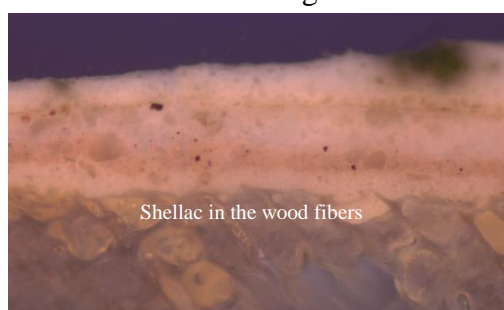
Ultraviolet Light 200X

UV Light & DCF for saturated and unsaturated lipids 200X

Weak + reactions for saturated (cross-linked) oils in all layers

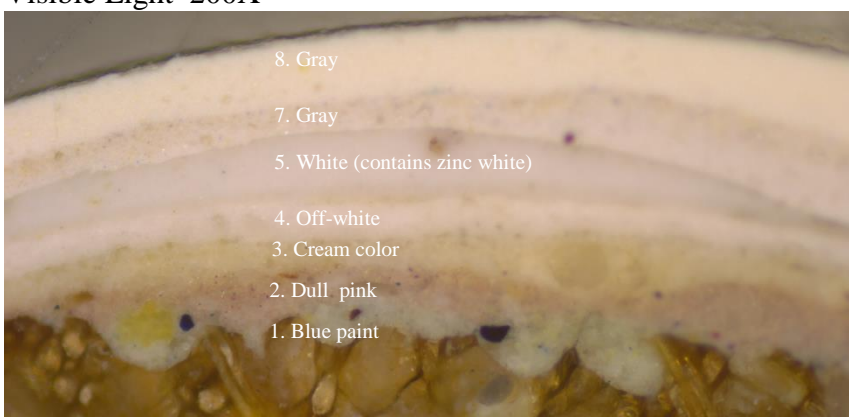
Sample 101-5. East wall, small applied molding on wainscot.  
Visible Light 200X

Sample 101-5. East wall, small applied molding on wainscot. The paint stratigraphy on the applied molding begins with a light blue paint that can be aligned with the first gray paint found on other areas of doors and trim in this room, and in the entry. This is part of the two-tone blue/gray paint scheme identified in this room. The second generation is the same dull pink paint found on the other trim elements, so it appears that this small molding was originally picked out with blue paint against a gray wainscot panel. In the second generation it was painted dull pink to match the center panel of the wainscot. Pigment identification with polarized light microscopy analysis shows that the first blue paint is composed of charcoal black, Prussian blue, white lead and calcium carbonate. All paints on this molding were confirmed as oil-bound with the biological fluorochrome stain DCF.

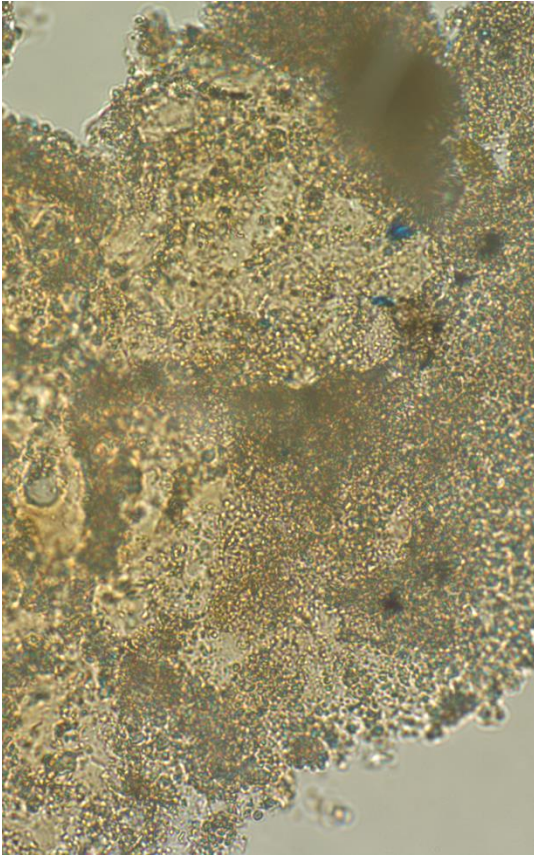
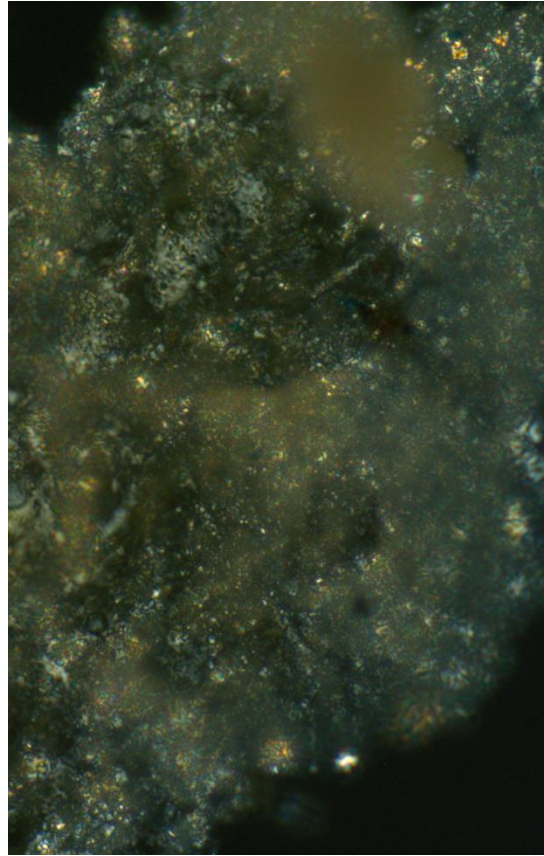
Sample 101-5. East wall, small applied molding on wainscot. Pigments in the first light blue-gray paint layer. Prussian blue, white lead, charcoal black and calcium carbonate.  
Plane polarized light 1000X                      Crossed polars (darkfield) 1000X

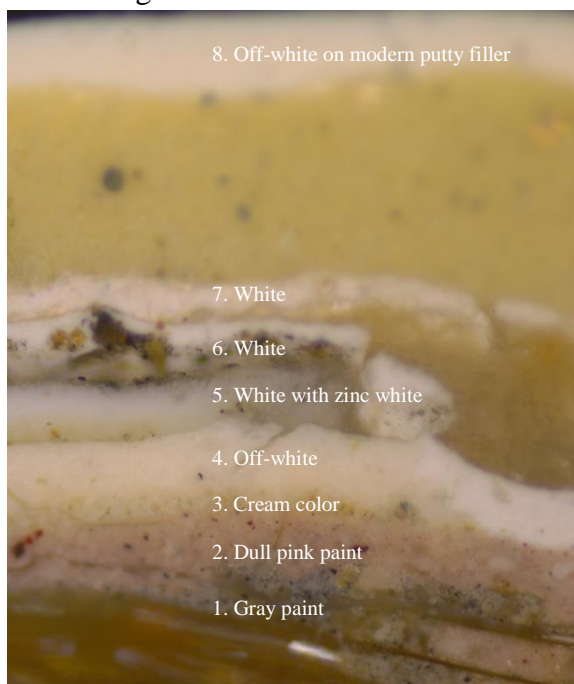
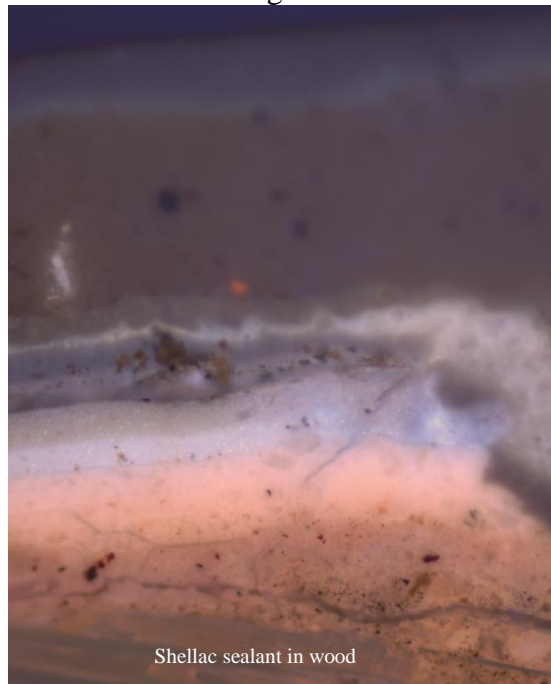
Sample 101-6. South wall, flat field of wainscot, southwest corner. The first gray paint on the wainscot is trapped deep in the wood, but it has an eroded surface indicative of it having been mostly cleaned or abraded away. Cleaning with a traditional caustic material such as lye in hot water would produce this type of eroded surface. The second generation is the dull pink paint found on other areas of woodwork in this room. This is followed by a series of cream-colored and off-white paint layers that can be aligned with the later woodwork coatings on other elements in the parlor. Pigment identification shows that the first gray woodwork paint is composed of charcoal black, lampblack, white lead and calcium carbonate.

Pigments in the gray paint layer. Charcoal black, white lead, lampblack, calcium carbonate.

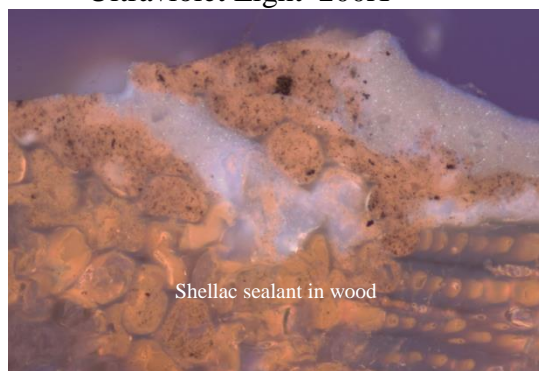
Ultraviolet Light 200X

UV Light & DCF for saturated and unsaturated lipids 200X

+ for saturated (cross-linked) oils in all layers

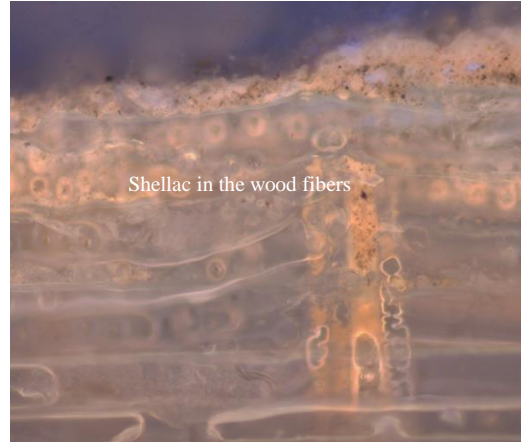
Ultraviolet Light 200X

UV & DCF for saturated and unsaturated lipids 200X

All layers reacted positively for saturated (cross-linked) lipids

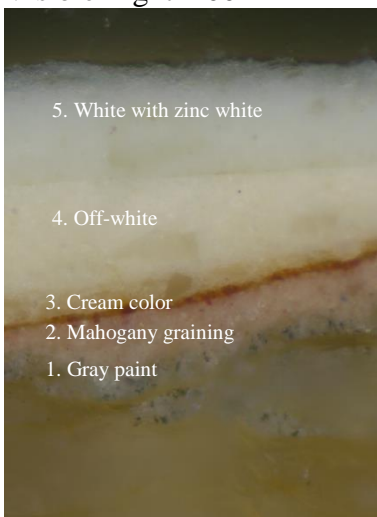
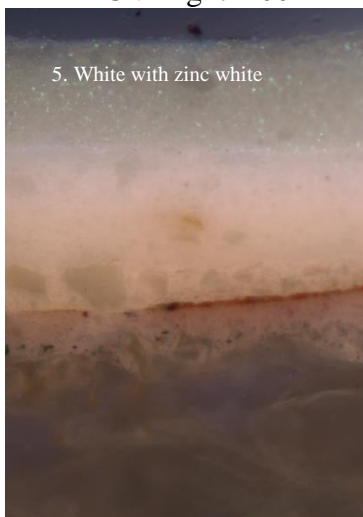
Visible Light 400X

UV Light 400X

UV Light & DCF for lipids

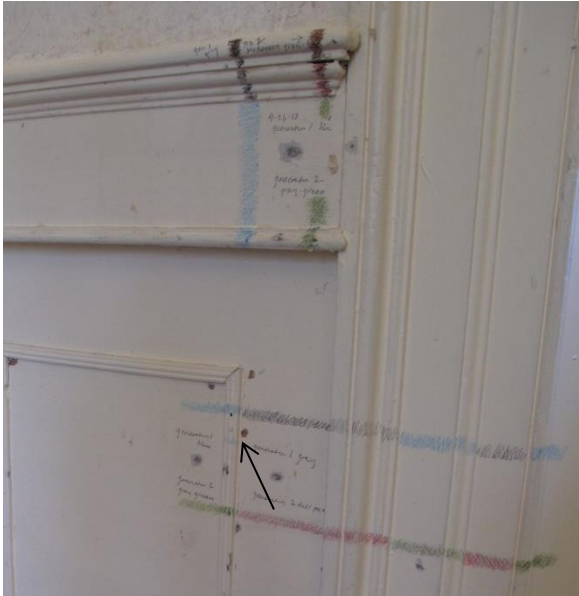
Sample 101-3SB. Wainscot, northwest corner, outer panel, right of applied molding.

The evidence in this cross-section helps to confirm that the outer portion of the wainscot panel was originally gray, then it was repainted dull pink in the second generation. All the subsequent layers are cream-colored and off-white paints which were all monochromatic paint schemes.

Visible Light 200X

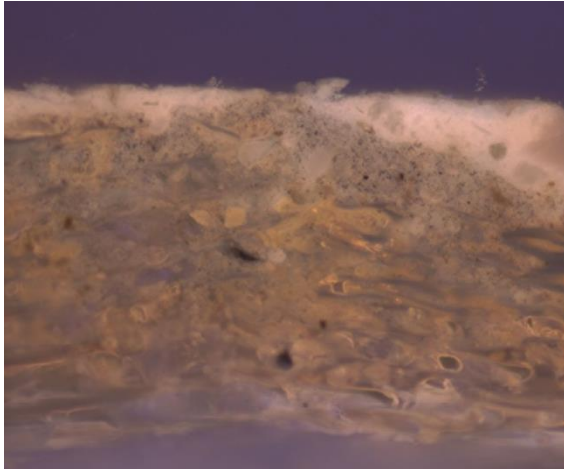
Sample 101-4SB. North wall east window, upper sash, upper right corner, upper pane.

The paints on the sashes are damaged from condensation, movement and reputtying, but a distinct layer of the original gray paint remains on top of the wood substrate. The second generation of paint is missing, but later cream-colored and off-white paints remain in the uncast portions of this sample. It appears that the sash were always painted to match the woodwork colors, although it is not clear whether the sashes were dull pink or dull green in the second generation.

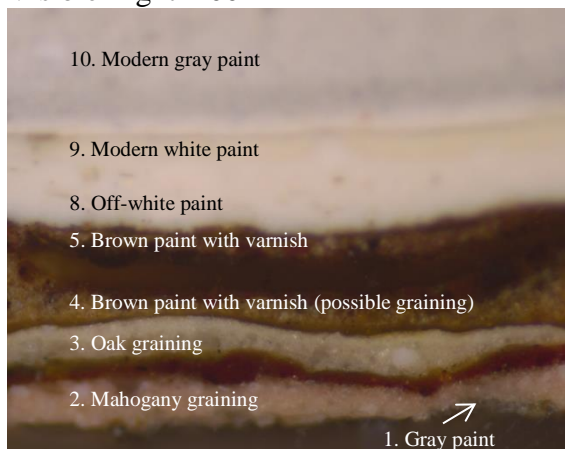
Sample 100-10. Door D1, south wall, possible varnish under layers of paint.  
Visible Light 200X

Sample 100-10. Door D1, south wall, possible varnish under layers of paint. The cross-section from the south wall door in the entry is surprisingly intact. This cross-section begins with the same dark gray paint found on the parlor door and baseboard. This is followed by what is likely a graining sequence to replicate mahogany, which consists of a pinkish base coat, a red-brown glaze and remnants of a varnish coating. The third generation is likely an oak graining sequences consisting of a cream-colored base coat, a thin brown glaze and a plant resin varnish coating. Generation 4 may also represent mahogany graining with a pinkish-brown base coat. Generation 5 is a brown paint with a varnish. The most recent paints are off-white and gray. If generation 3 is the target period for interpretation of the parlor and entry, then it seems that this door was oak-grained in the same manner on both sides. Fluorochrome binder analysis confirms that all the paints in this coating sequence are traditional oil-bound paints.

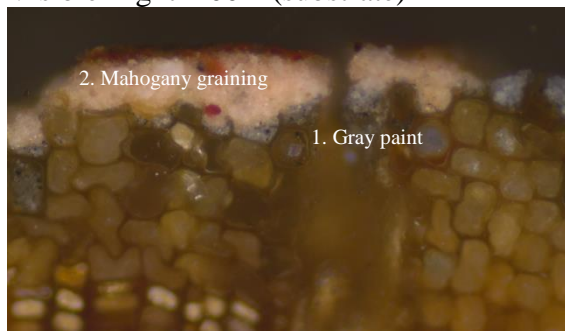
Visible Light 200X (substrate)

Ultraviolet Light 200X

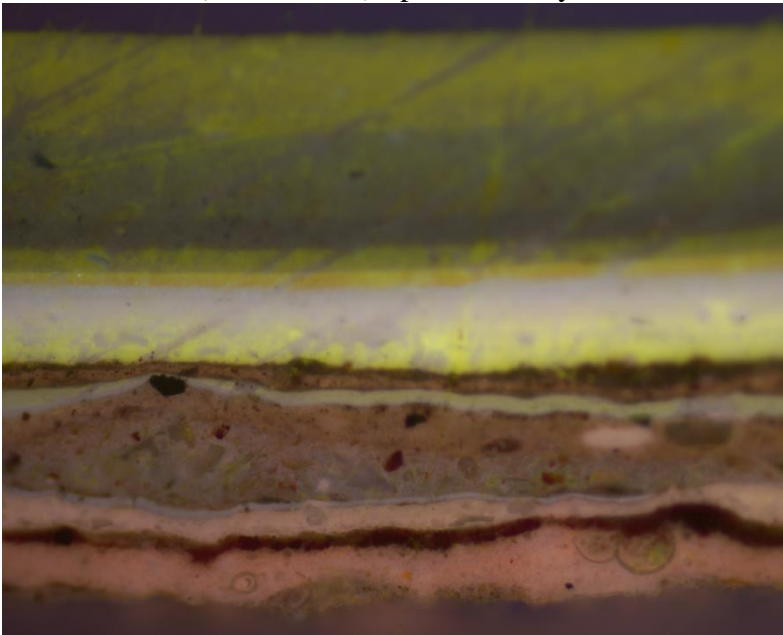
Sample 100-10. Door D1, south wall, possible varnish under layers of paint.  
UV & DCF for saturated and unsaturated lipids 200X  
+ for saturated (cross-linked) lipids in all layers

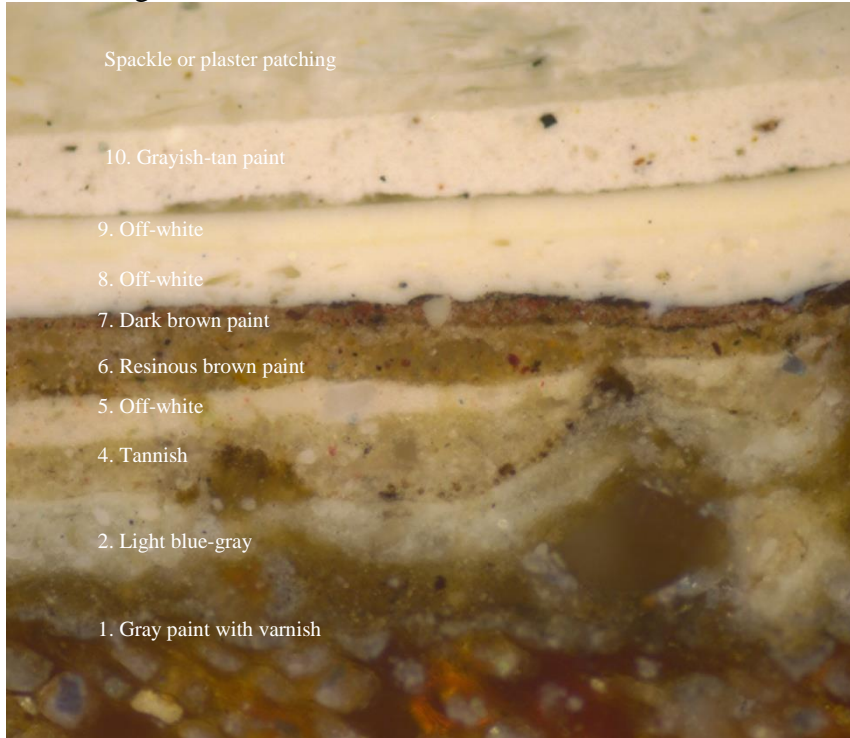
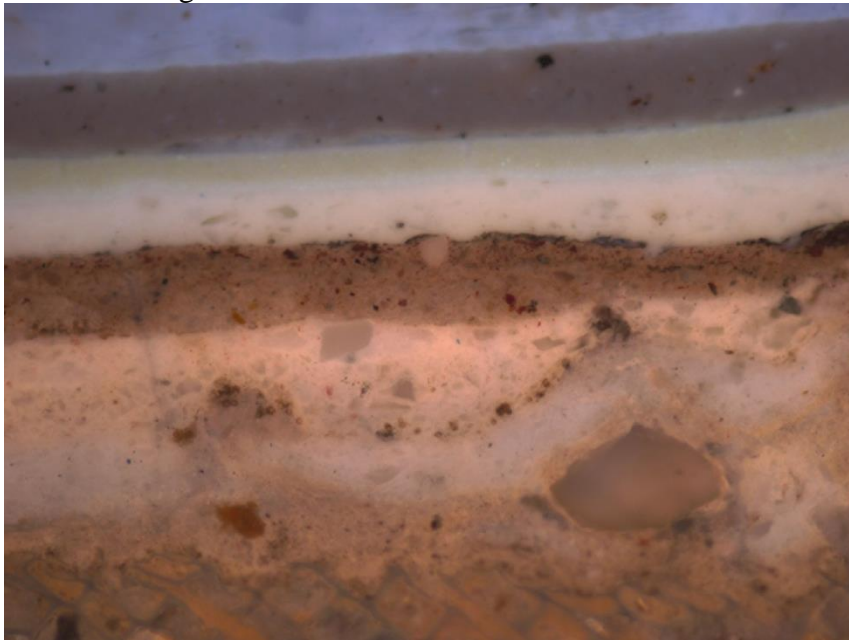
Sample 100-11. North wall, back door architrave (similar to 12 and 18).  
Visible Light 200X

Sample 100-11. North wall, back door architrave (similar to 12 and 18). Sample 100-12 retains an almost complete paint stratigraphy. The cross-section sample is missing the cream-colored paint applied in generation 3, but this layer is present in the uncast portions of this sample.

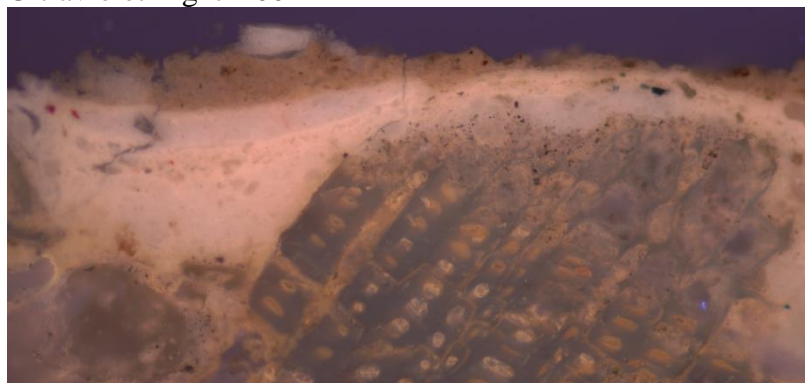
Gray paint is eroded and cracked

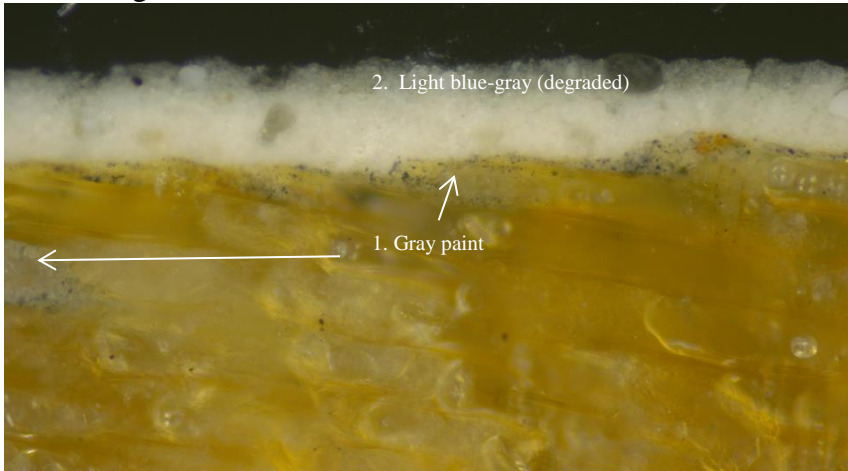
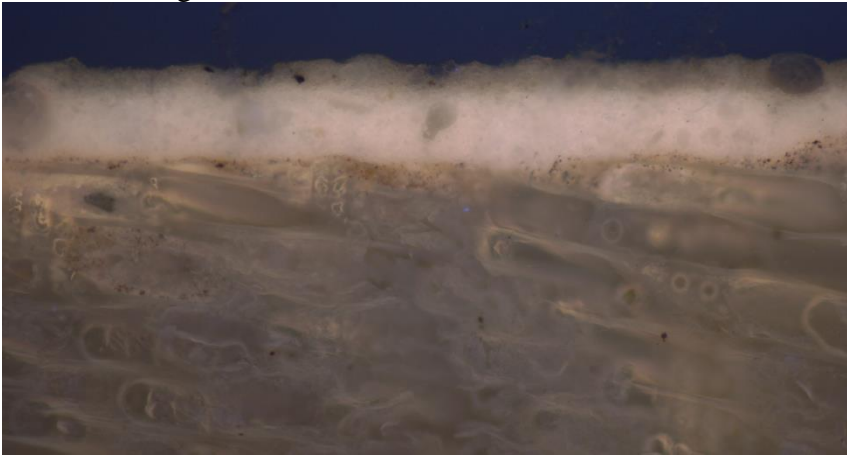
Sample 100-13. South wall, surbase east of doorway.  
Visible Light 200X

Sample 100-13. South wall, surbase east of doorway. The evidence of an uneven film of gray paint on the surface of the wood, and trapped in the wood fibers, is consistent with woodwork that has lost most of its original paint. This sample helps to confirm that the surbase was originally the same gray as the tripartite doorway woodwork. The second generation represents the light blue-gray paint, but the layer appears bleached and eroded in this cross-section. Uncast portions of the surbase sample retain the later paints observed on the architraves and another area of surbase (100-3SB).

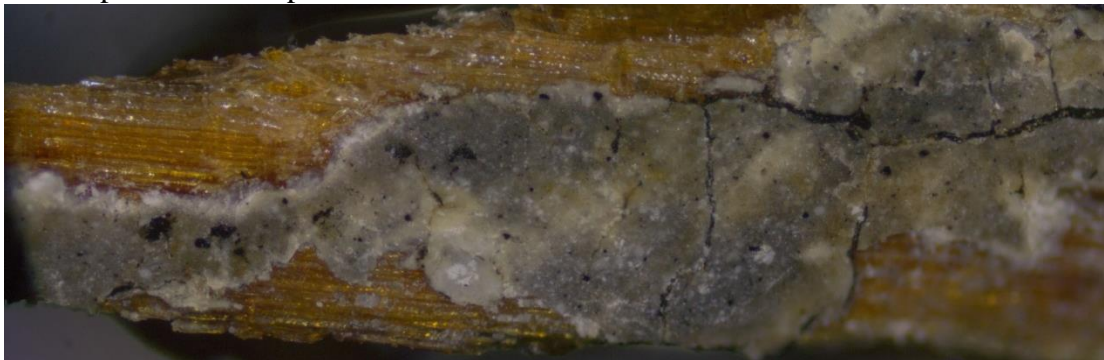
Uncast portion of sample 100-4SB

Sample 100-4SB. West wall, baseboard plinth just south of parlor door. One sample from below the stair in the entry was analyzed for comparison with the two baseboard samples (101-3 and 4) from the parlor. There are traces of the first gray paint that was found on one section of baseboard in the parlor in uncast portions of this sample. This gray paint is followed by a cream-colored base coat and a gray paint. A second baseboard sample was taken for analysis during the April site visit (100-4SB) and it helps to confirm that the baseboard was originally gray. The baseboard may have been marbled to simulate a gray stone in generation 2, with a cream-colored base coat and two different gray glazes.

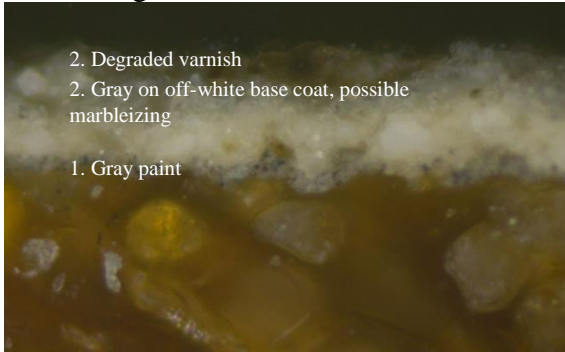
Sample 100-4SB. West wall, baseboard below location of 100-3SB.

Visible Light 400X

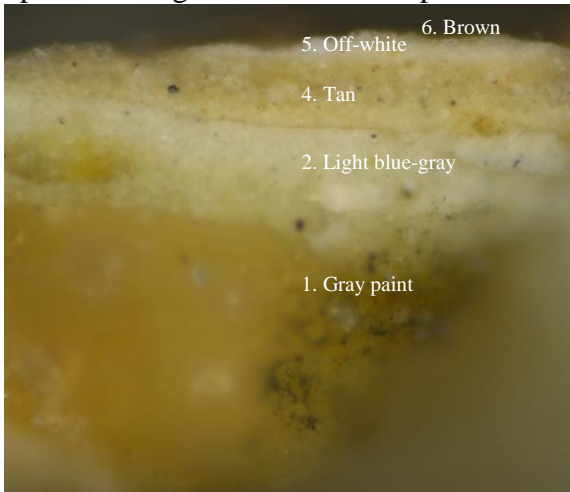
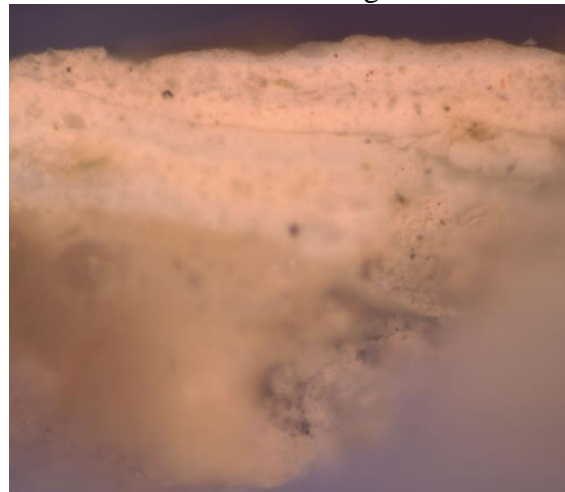
Sample 100-2SB. Tripartite window, left architrave of left sidelight, about 5-feet up. Visible Light 200X      Separated flake      Ultraviolet Light 200X

Sample 100-2SB. Tripartite window, left architrave of left sidelight, about 5-feet up.  
Samples from the tripartite window architrave confirm the woodwork was initially painted gray, followed by light blue-gray in the second generation. The third generation cream-colored paint is missing the cast cross-section, but is present in uncast portions of the same sample.

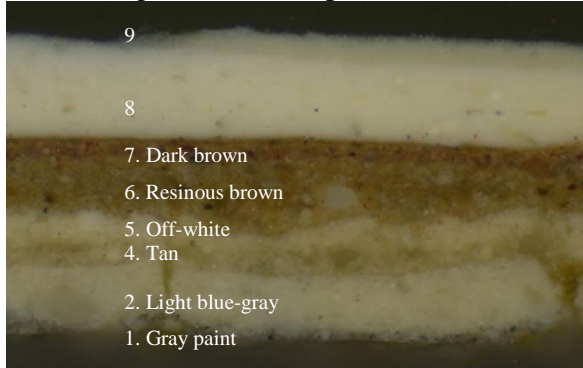
Sample 100-3SB. Surbase, west wall, right of door.

Visible Light 200X Separated flake

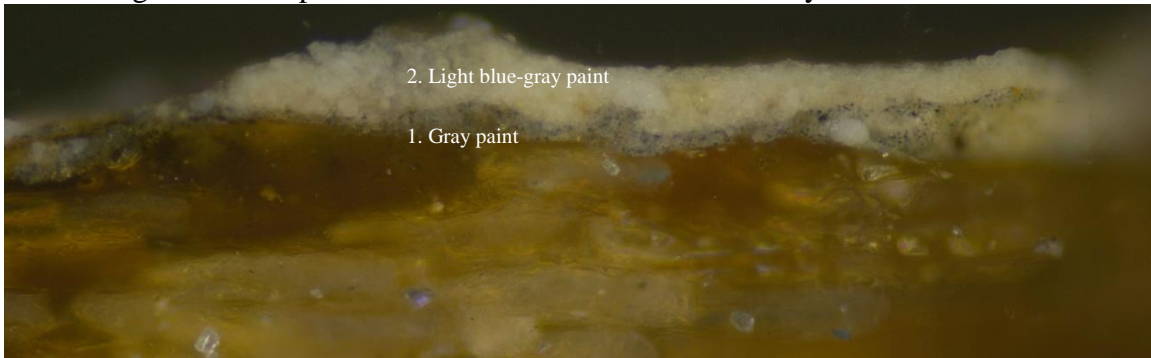
Sample 100-5SB. North wall, window at landing, upper left corner of lower sash.  
Visible Light 200X expanded to show details of the earliest layers

Sample 100-5SB. North wall, window at landing, upper left corner of lower sash. Very little paint remains on the sash, most likely because of general repairs to the sash, as well as to flaking from condensation and movement. The three earliest paints remain on protected areas of the sash, indicating that the sash was painted the same color as the rest of the woodwork from generations 1 through 3.

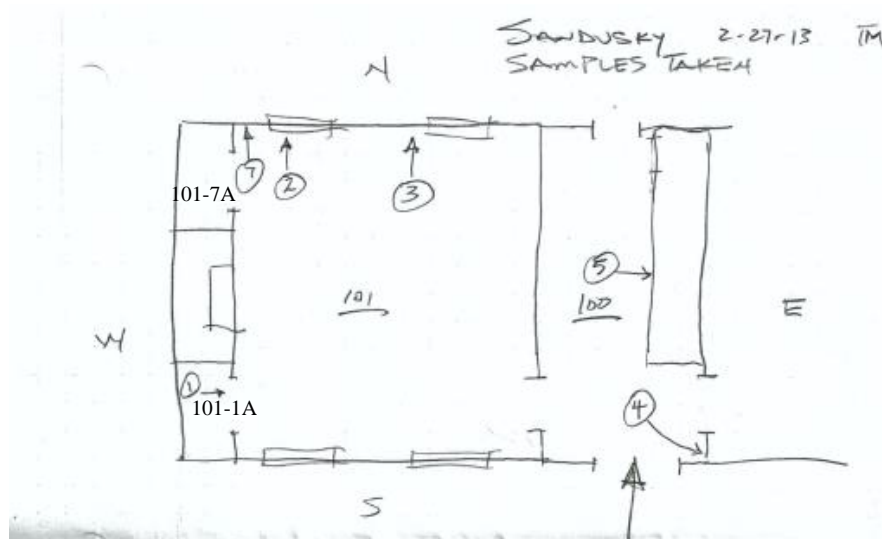
101-7A. North wall, to the left west window. Looks like 1950s plaster – should have modern history.

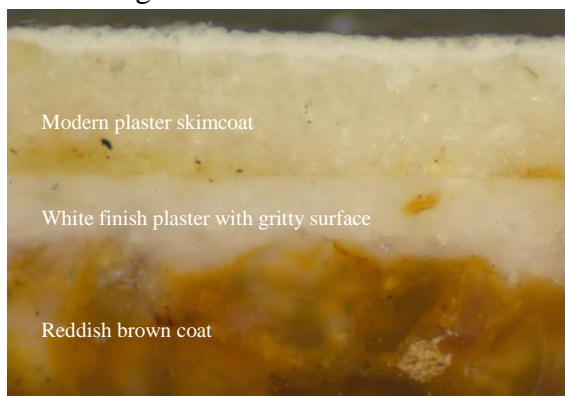
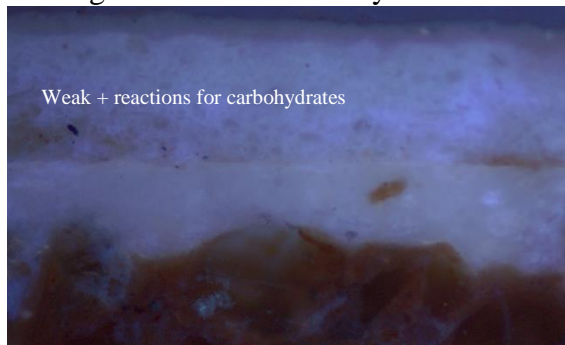
Sample 101-1. Wall plaster from south wall between windows at about 6' above floor.

Visible Light 100X

UV Light & TTC for carbohydrates

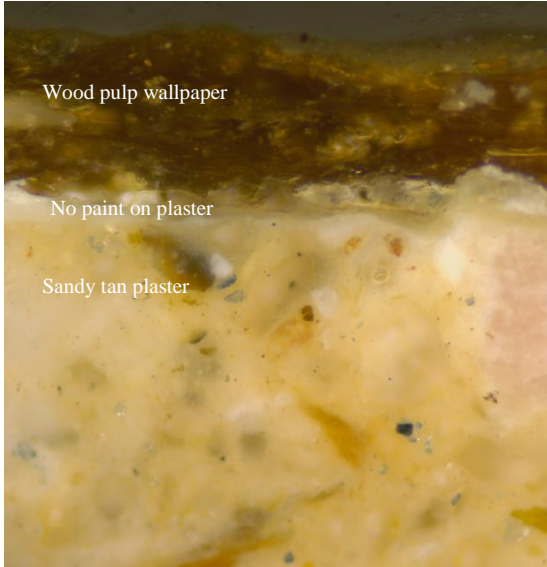
Sample 101-3. Wall plaster from inside of south alcove, east wall above arch on riven lath. This sample was taken with attached wallpaper, and McDonald noted that the: “Soft tan mortar is different from soft reddish mortar and is possibly first period mortar”. In this cross-section it appears that all early wall paint and wallpaper evidence was removed, leaving the more recent wood pulp-based wall paper directly adhered to the sandy tannish plaster.

Visible Light 100X

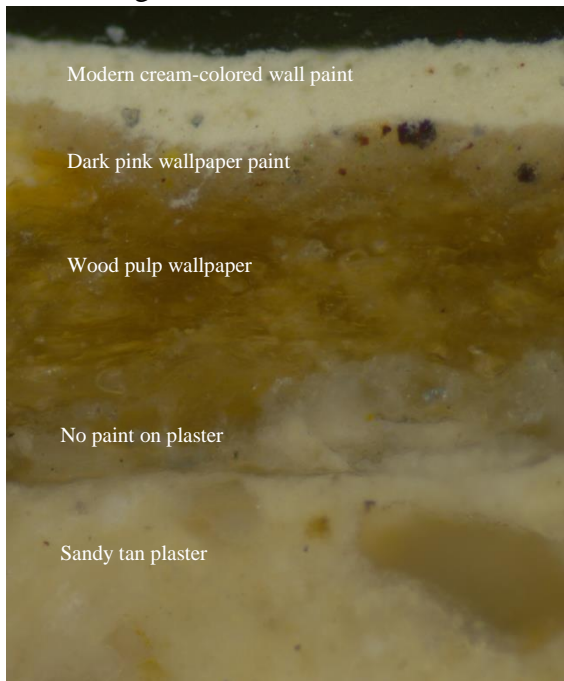
Sample 101-1A. South arch inside alcove (compare to 101-9).

Visible Light 200X

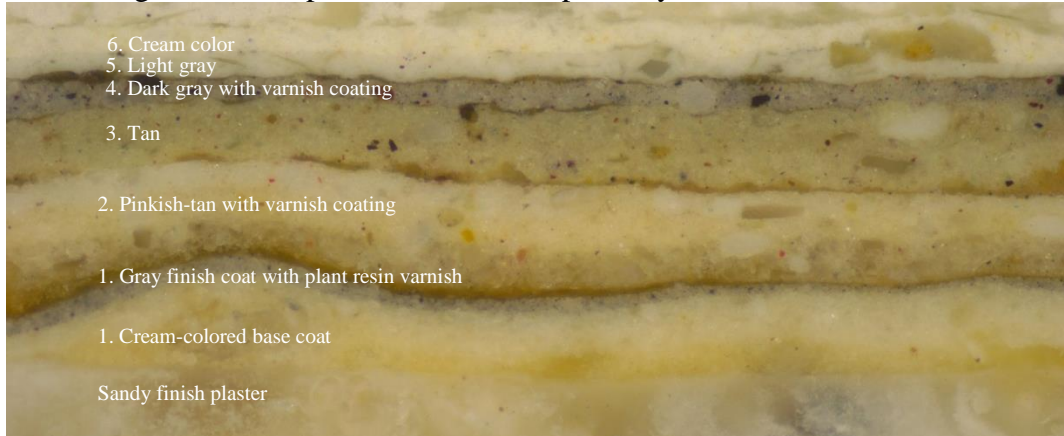
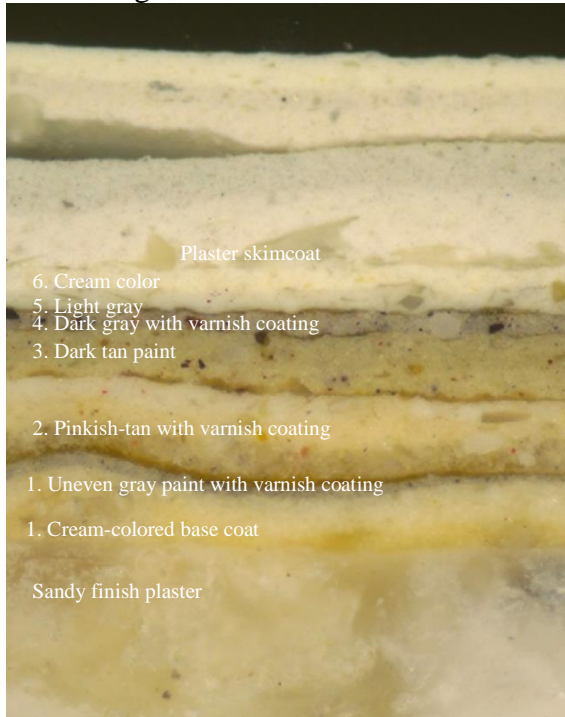
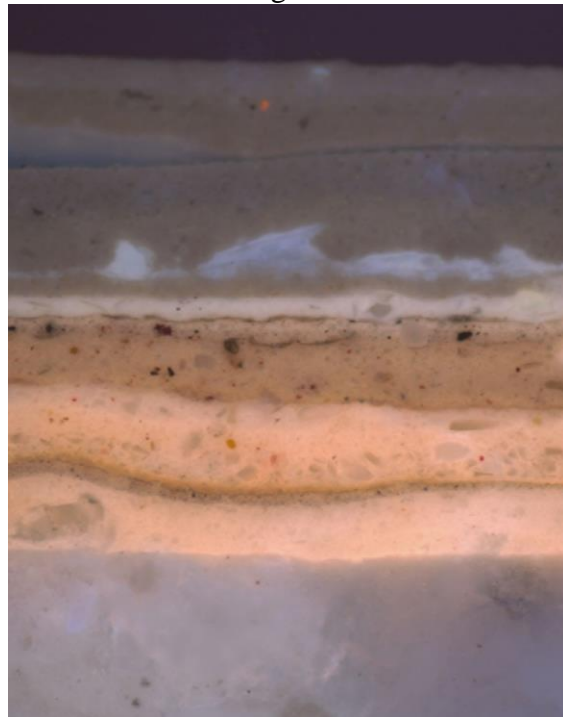
Sample 100-1SB. Plaster wainscot, east wall along stair, early plaster?  
Visible Light 200X

Sample 100-5SB contains what seems to be a complete chronology, with approximately ten generations of paints, beginning with the first three observed in sample 100-5A. But it is even more obvious in this sample that the first generation of paint may be some sort of faux-painted finish because of the uneven nature of the gray layer and the consistent varnish application. Layer-by-layer overpaint removal would be required to reveal any pattern or design in the original finish sequence. If the walls were repainted at the same time as the woodwork, then generation 2, the pinkish-tan, may date to approximately 1826 and generation 3, the tan paint, may date to 1849. The dark gray paint that can be seen on the walls where more recent paints have been removed is generation 4 in sample 100-1SB.

Based on the evidence in samples 100-1SB and 100-5A the wall paint stratigraphy below the chair rail in the entry can be reconstructed in the following manner:

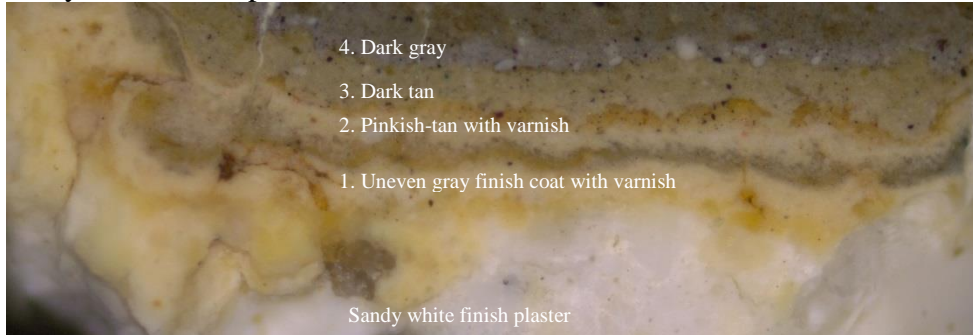
Uncast portion of sample 100-1SB photographed at 40X to show the earliest layers on the sandy white finish plaster

The samples taken from under the current wallpaper seem to represent paint schemes that were applied only above the chair rail, not below the chair rail, as none of the coating layers match up with samples 100-1SB or 100-5A. When the cross-sections are compared it is possible to see that the sandy whitish plaster substrate is the same in all the samples, and that the first cream-colored distemper on the plaster above the chair rail may relate to the possible gray faux finish below the chair rail. Similarly, the second generation above the chair rail seems to consist of a lavender base coat paint with a thin red layer, possible a decorative design layer, above the lavender paint. The absence of any other early paint evidence above generation 2 suggests the walls were wallpapered on top of the lavender paint scheme.

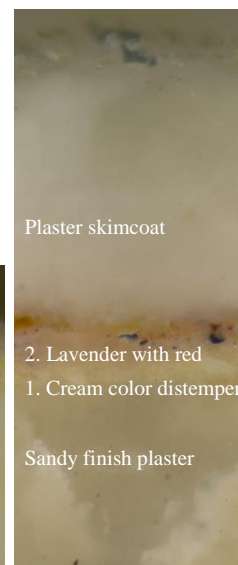
100-12

Sample 100-12. Taken from under current wallpaper to the left of the door into room 101 at just above the chair rail area. This sample was taken from an area of wall thought by Travis McDonald to be original plaster. There are three thin, slightly translucent coatings on top of whitish plaster that could represent two periods of decoration. The first layer is a cream-colored distemper (pigments bound in dilute hide glue) that has a thin film of dirt on its surface. The second generation appears to be two thin layers of distemper – deep lavender followed by red – that may represent an early decorative scheme. There is a later white bright skimcoat of plaster which has trapped these early paints. All the layers in the cross-section reacted positively for the presence of proteins with the fluorochrome FITC for proteins. The distemper paints in this sample are essentially the same as those found in sample 100-4A.

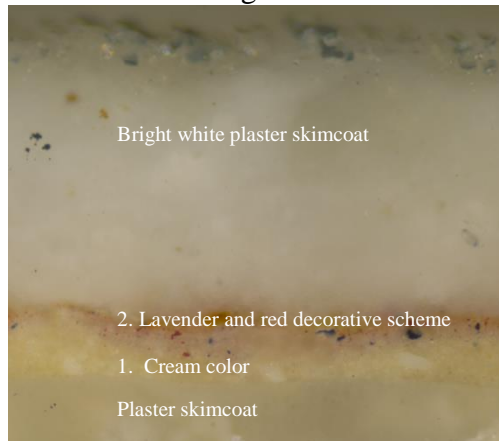
Visible Light 200X

Sample 100-12. Taken from under current wallpaper to the left of the door into room 101 at just above the chair rail area.

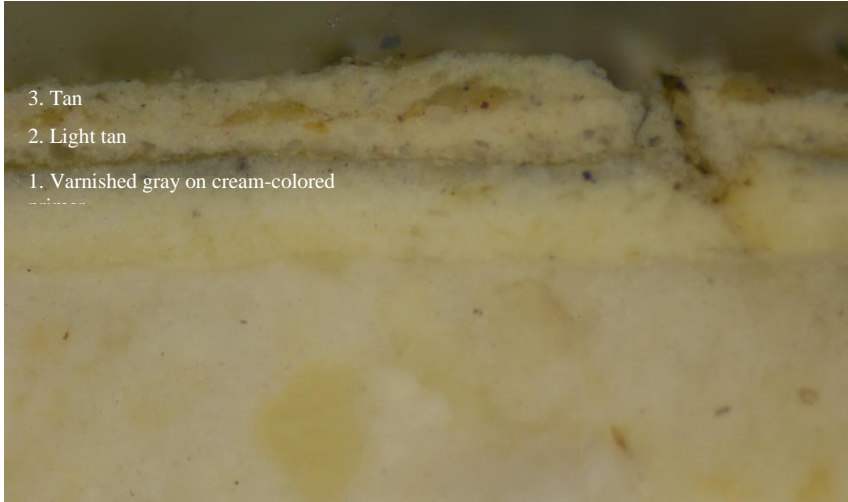
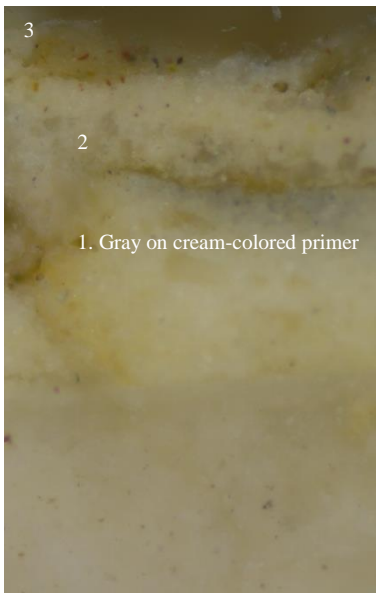
Sample 100-5A. Plaster under stair. (Compare to #100-12).

Visible Light 200X

Visible Light 400X

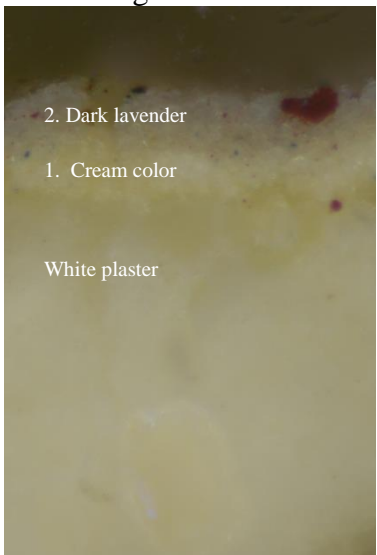
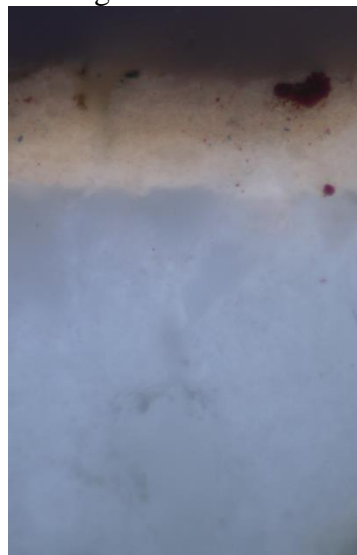
Visible Light 400X

UV Light 400X

UV Light & DCF for lipids
