## **Cross-section Paint Microscopy Report**

### **Interior Paints Historic Sandusky, Lynchburg, Virginia**

Date: May 31, 2013

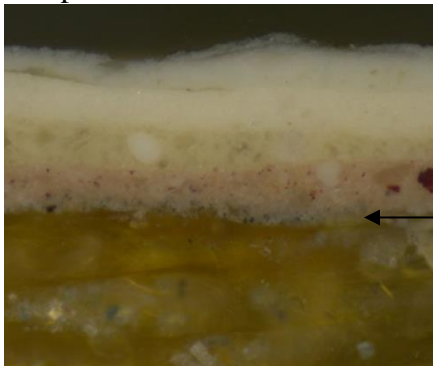
Sample 101-3SB

The ca. 1810-12 gray woodwork and baseboard paint was too darkened and degraded to match accurately, so a color match was made by eye at 30X under a color-corrected light source. The commercial match #2132-40 is an excellent visual match to best surviving areas of the original gray oil-bound woodwork paint.

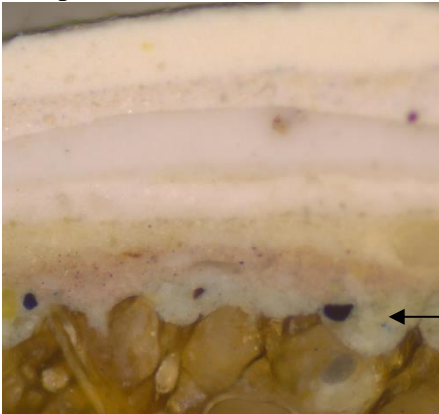
Sample 101-5

The ca. 1810-12 blue woodwork paint was too darkened and degraded to match accurately, so a color match was made by eye at 30X under a color-corrected light source. The commercial match #HC-148 is an excellent visual match to best surviving areas of the original blue woodwork paint used as part of a two-tone palette.

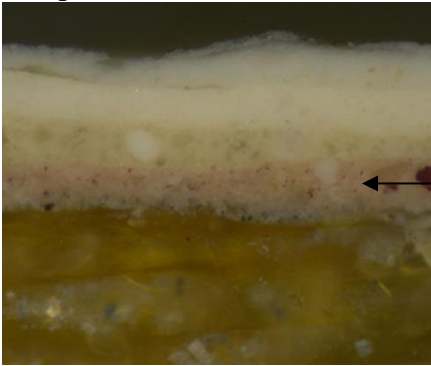
Sample 101-3SB

The ca. 1826 pink woodwork paint was too darkened and degraded to match accurately, so a color match was made by eye at 30X under a color-corrected light source. The commercial match #2173-40 is an excellent visual match to best surviving areas of the second-generation pink paint used as part of the two-tone palette for the woodwork.

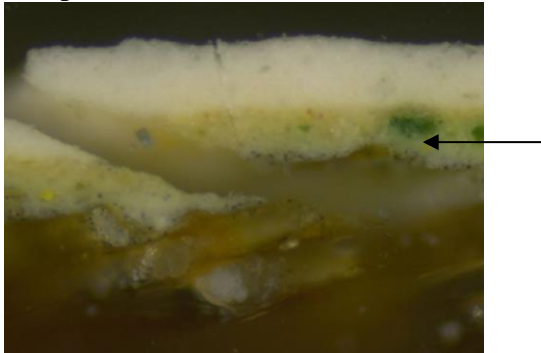
Sample 101-2SB

The ca. 1826 green woodwork paint was too darkened and degraded to match accurately, so a color match was made by eye at 30X under a color-corrected light source. The commercial match #HC-132 is an excellent visual match to best surviving areas of the green paint used as part of the two-tone palette in this room.

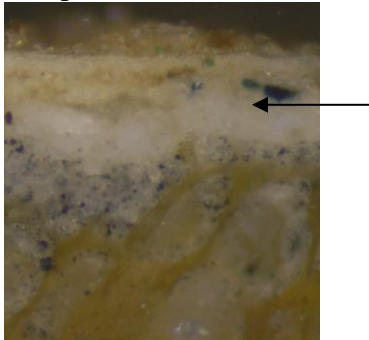
Sample 100-12

The ca. 1826 blue-gray woodwork paint was too darkened and degraded to match accurately, so a color match was made by eye at 30X under a color-corrected light source. The commercial match #2131-50 is an excellent visual match to best surviving areas of the monochromatic blue-gray paint in this passage.

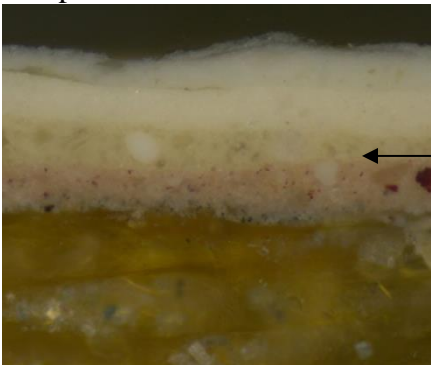
Sample 101-3SB

The ca. 1849 cream-colored woodwork paint was too darkened and degraded to match accurately, so a color match was made by eye at 30X under a color-corrected light source. The commercial match #OC-36 is an excellent visual match to best surviving areas of the third-generation cream-colored paint.
